Fish Barrier Survey of Twelve Mile Creek (Effingham Branch) Project

Submitted in order to fulfill the requirements of the Field Project course of the
Ecosystem Restoration program at Niagara College, 2021-22

Prepare For: Trout Unlimited Canada – Niagara Chapter

Date: April 22, 2022

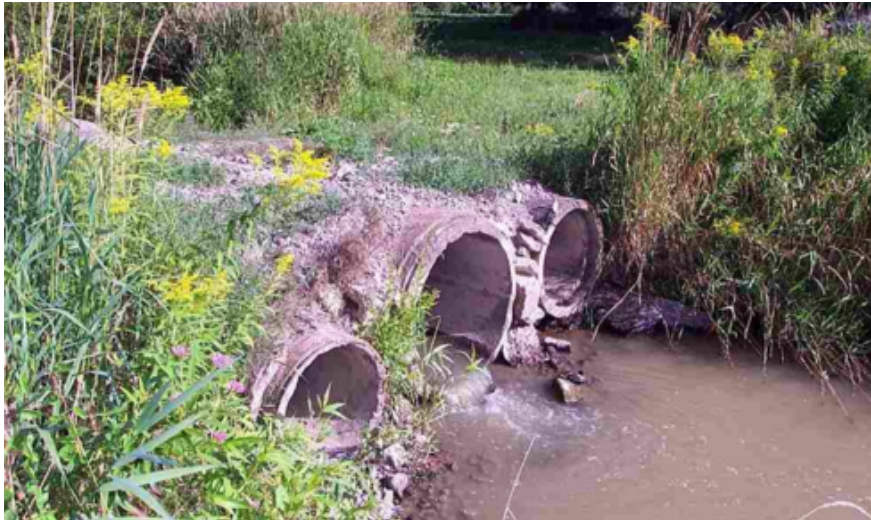
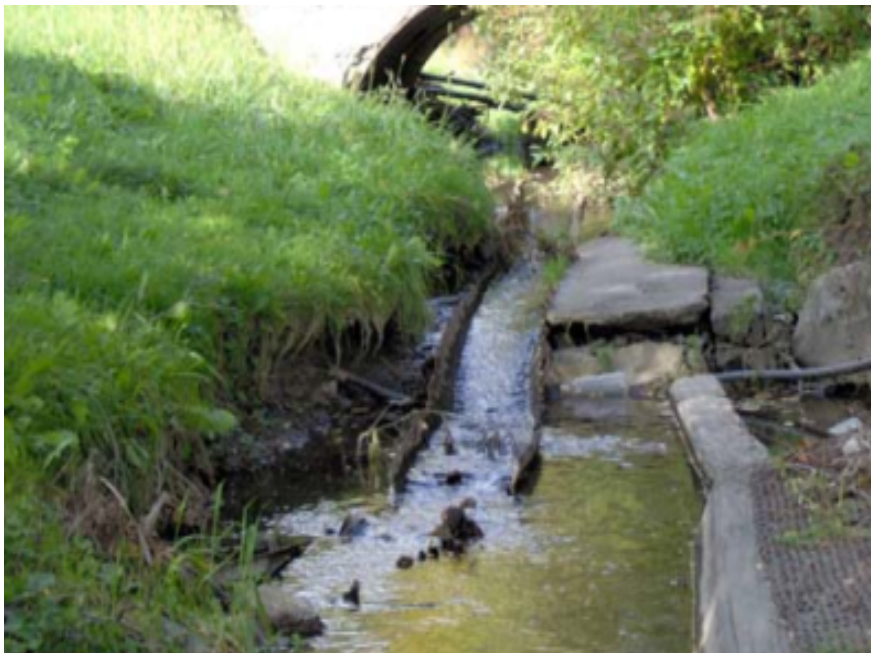
not allow fish to travel back upstream through the culvert (figure 3a). Another example of a high priority barrier is a large fallen log that blocks the entire flow of water for a long time or creates a waterfall which fish cannot pass. An intermediate barrier may be debris or sediment that blocks some, but not all the stream's flow (figure 3b). A minor barrier may be something such as a bridge support which has little effect on the natural flow of water but could become a bigger barrier if debris were to build up on it. The same goes for a culvert.

Figure 3. A) Perched culverts. B) Debris restricting the stream. These are examples of fish barriers found in the Niagara River Area of Concern (AOC) - Fish Barrier Project (Niagara Restoration Council, Niagara Peninsula Conservation Authority, 2007)

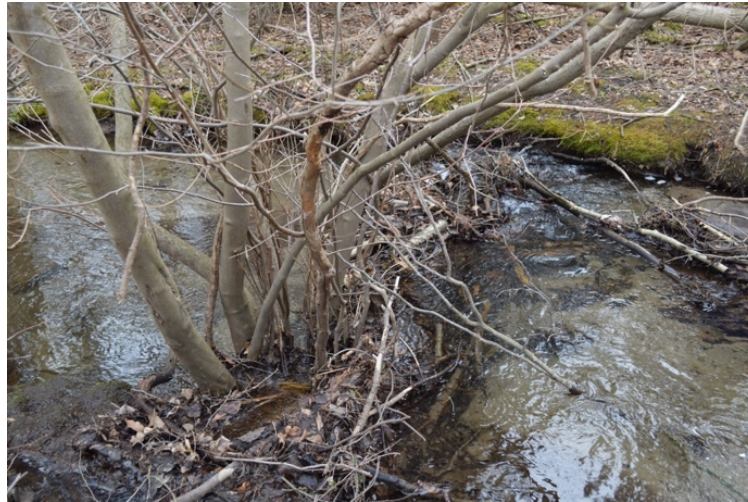
Name	TS1
Priority level	Minor
Coordinates	43.0683068, -79.32261877
Property/Nearest Location	Agape Valley, 392 Kilman Rd Pelham ON
Barrier Description	Woody debris has built up across the creek, only allowing water to flow across the side of the creek.

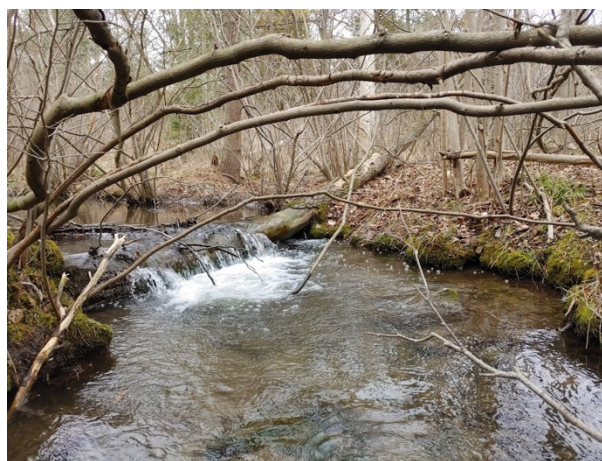
Name	TS2
Priority level	Major
Coordinates	43.068333, -79.322222

Property/Nearest Location	Agape Valley, 392 Kilman Rd Pelham ON
Barrier Description	A large tree has fallen over onto the creek, creating a waterfall that prevents movement of fish upstream

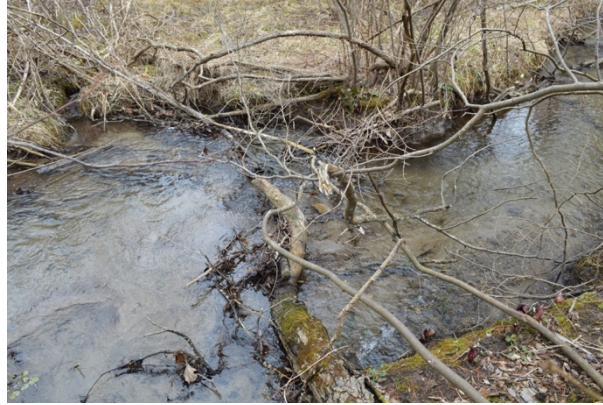
Name	TS3
Priority level	Minor
Coordinates	43.068056, -79.322222
Property/Nearest Location	Agape Valley, 392 Kilman Rd Pelham ON
Barrier Description	A small tree has fallen and stuck with debris on the creek, blocking some of the flow of water.

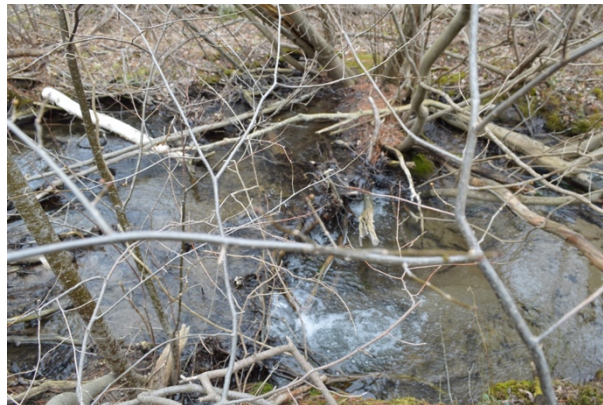
Name	TS4
Priority level	Intermediate
Coordinates	43.068056, -79.321944
Property/Nearest Location	Agape Valley, 392 Kilman Rd Pelham ON
Barrier Description	The roots of trees go across to the creek and are built up with debris, causing a waterfall in the area.

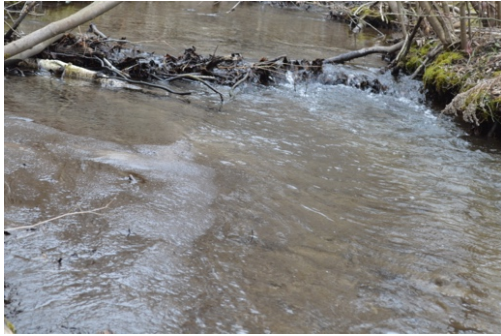
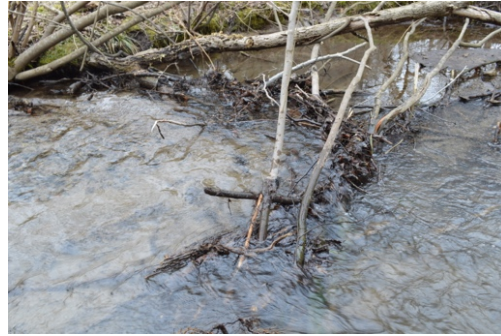
Name	TS5 (1), (2)
Priority level	Minor
Coordinates	43.068333, -79.321333
Property/Nearest Location	Agape Valley, 392 Kilman Rd Pelham ON
Barrier Description	Woody debris has built up across the creek. This area has two barriers, and sediment has built up in between them.

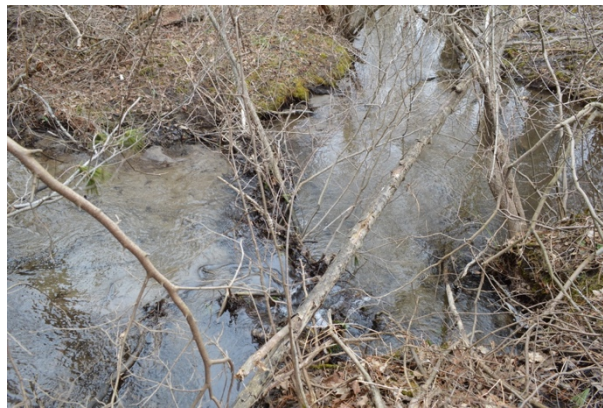
Name	TS6
Priority level	Minor
Coordinates	43.068056, -79.320833
Property/Nearest Location	Agape Valley, 392 Kilman Rd Pelham ON
Barrier Description	The creek is blocked by debris.

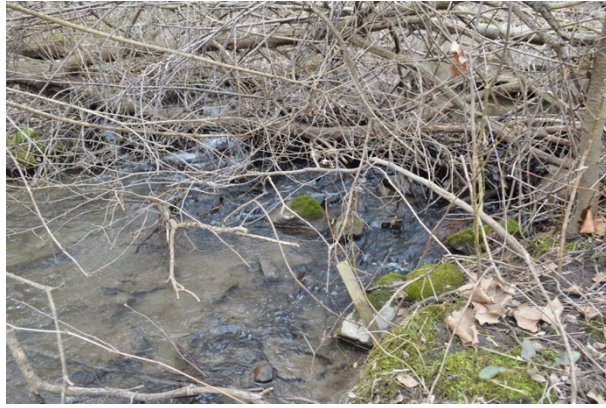
Name	TS7
Priority level	Minor
Coordinates	43.068333, -79.320278
Property/Nearest Location	Agape Valley, 392 Kilman Rd Pelham ON
Barrier Description	Small trees have fallen on the creek and some debris has stuck on it, blocking a small part of the creek.

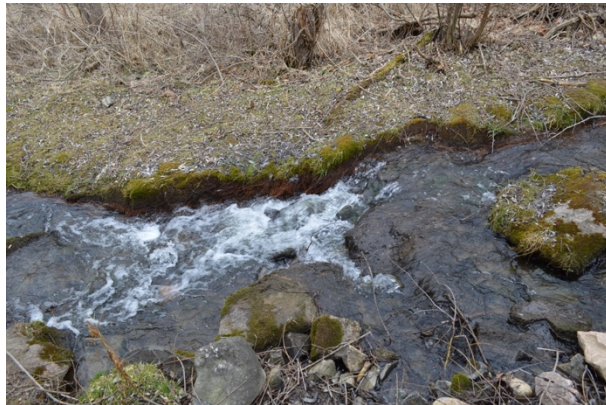
Name	TS8
Priority level	Intermediate
Coordinates	43.068333, -79.319444
Property/Nearest Location	Agape Valley, 392 Kilman Rd Pelham ON
Barrier Description	Multiple large rocks in the creek have created a small waterfall.

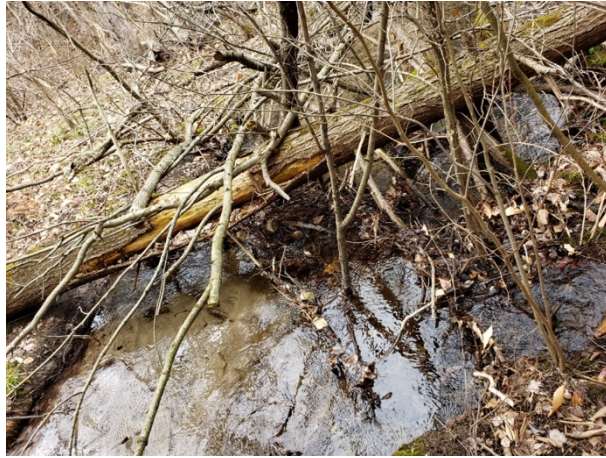
Name:	AJ1
Priority level:	Minor
Coordinates:	43.067539, -79.324510
Property/Nearest Location:	Agape Valley, 392 Kilman Rd Pelham ON
Barrier Description:	Fallen trees, leaf litter build up

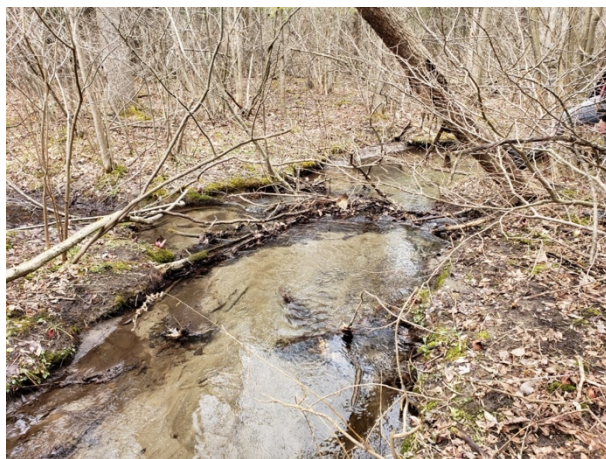
Name:	AJ2
Priority level:	Intermediate
Coordinates:	43.067269, -79.3246509
Property/Nearest Location:	Agape Valley, 392 Kilman Rd Pelham ON
Barrier Description:	Fallen branches, leaf litter

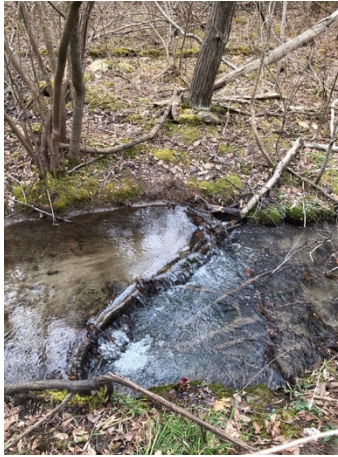
Name:	AJ3
Priority level:	Minor
Coordinates:	43.067154, -79.3246318
Property/Nearest Location:	Agape Valley, 392 Kilman Rd Pelham ON
Barrier Description:	Fallen tree, small waterfall

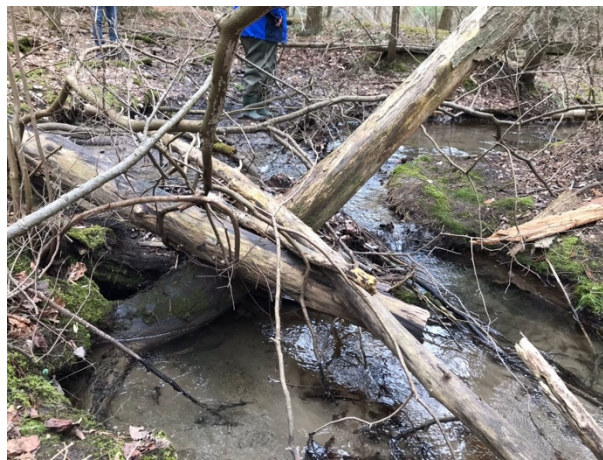
Name:	AJ4
Priority level:	Minor
Coordinates:	43.0669352, -79.3247320
Property/Nearest Location:	Agape Valley, 392 Kilman Rd Pelham ON
Barrier Description:	Fallen tree, leaf litter

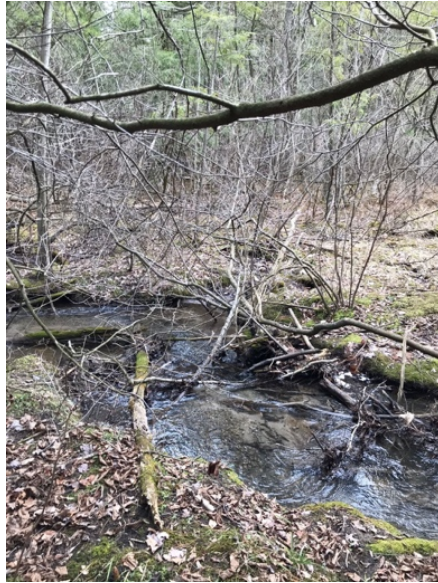
Name:	AJ5
Priority level:	Minor
Coordinates:	43.066673, -79.324819
Property/Nearest Location:	Agape Valley, 392 Kilman Rd Pelham ON
Barrier Description:	Fallen tree, leaf litter

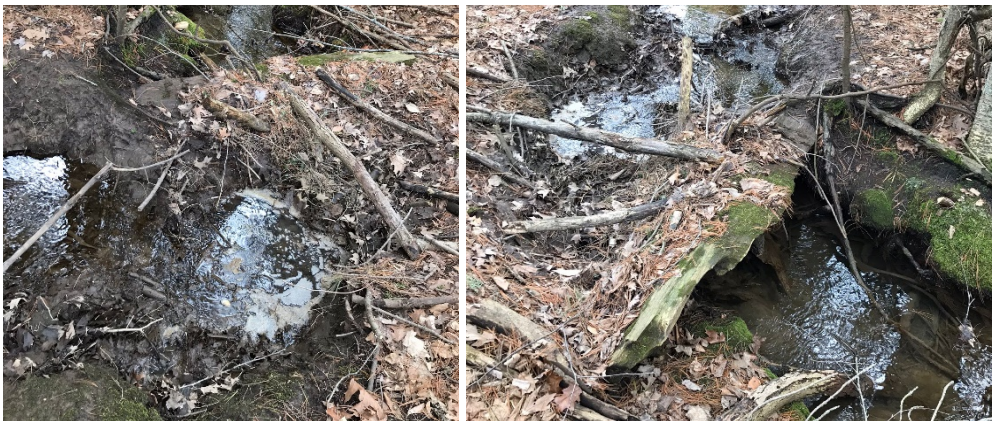
Name:	JP1
Priority level:	Major
Coordinates:	43.0649690, -79.3248001
Property/Nearest Location:	Agape Valley, 392 Kilman Rd Pelham ON
Barrier Description:	Split tree trunk, sediment build up and leaf litter

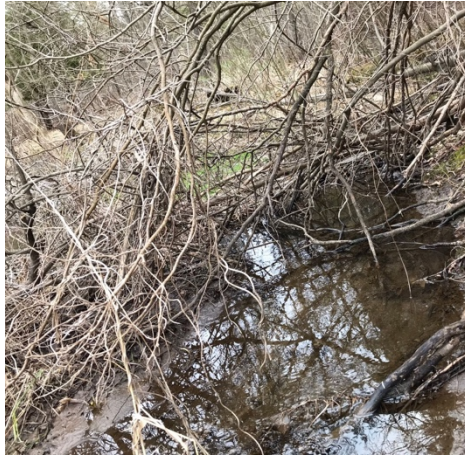
Name:	JP2
Priority level:	Intermediate
Coordinates:	43.064206, -79.324974
Property/Nearest Location:	Agape Valley, 392 Kilman Rd Pelham ON
Barrier Description:	Fallen branches, leaf litter

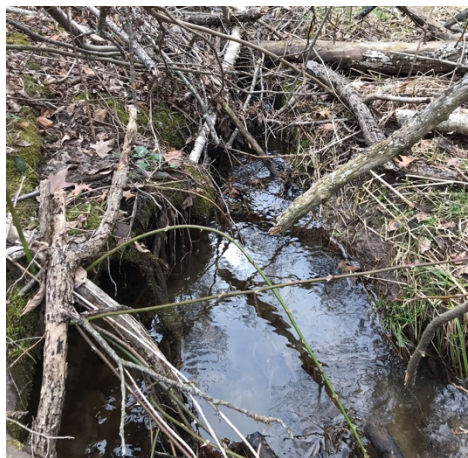
Name:	JP3
Priority level:	Intermediate
Coordinates:	43.063889, -79.325000
Property/Nearest Location:	Agape Valley, 392 Kilman Rd Pelham ON
Barrier Description:	Fallen logs, branches, leaf litter

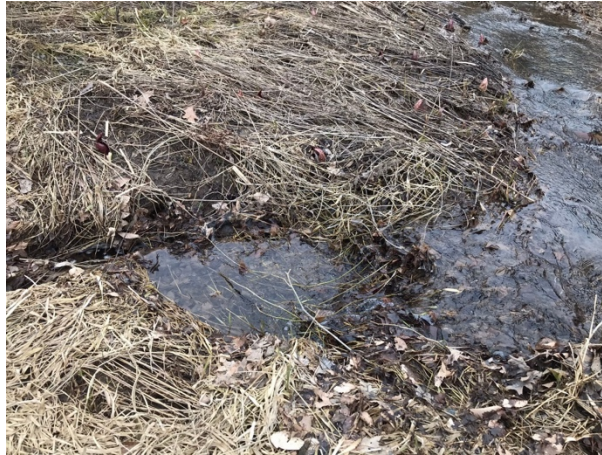
Name:	JP4
Priority level:	Intermediate
Coordinates:	43.063497, -79.325166
Property/Nearest Location:	Agape Valley, 392 Kilman Rd Pelham ON
Barrier Description:	Grass and leaf litter build up, elevation change, small waterfall

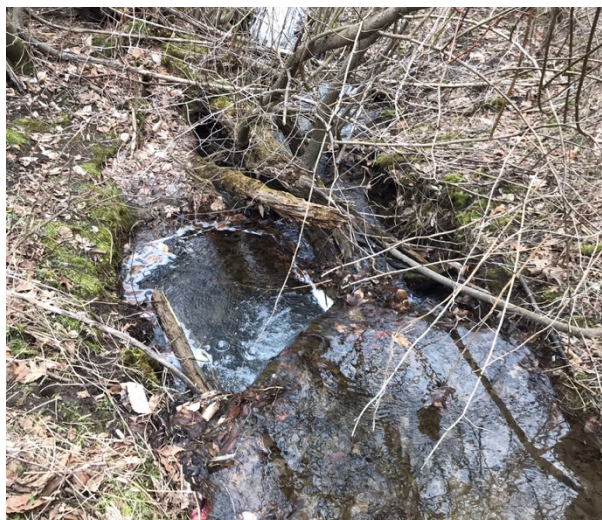
Name:	JP5
Priority level:	Major
Coordinates:	43.0629550, -79.3254552
Property/Nearest Location:	Short Hills Nature Park Pelham ON
Barrier Description:	Fallen logs, branches

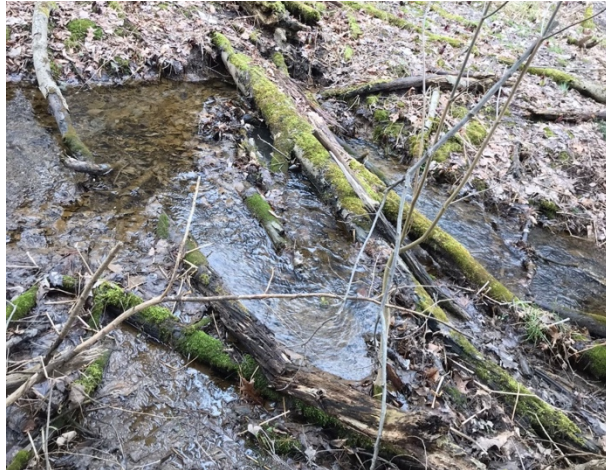
Name:	JP6
Priority level:	Major
Coordinates:	43.062427, -79.326619
Property/Nearest Location:	Short Hills Nature Park Pelham ON
Barrier Description:	Fallen tree, logs

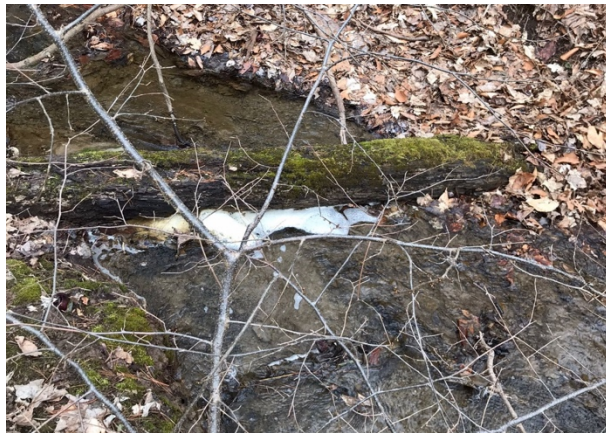
Name:	JP7
Priority level:	Major
Coordinates:	43.0616577, -79.3271936
Property/Nearest Location:	Short Hills Nature Park Pelham ON
Barrier Description:	Fallen log

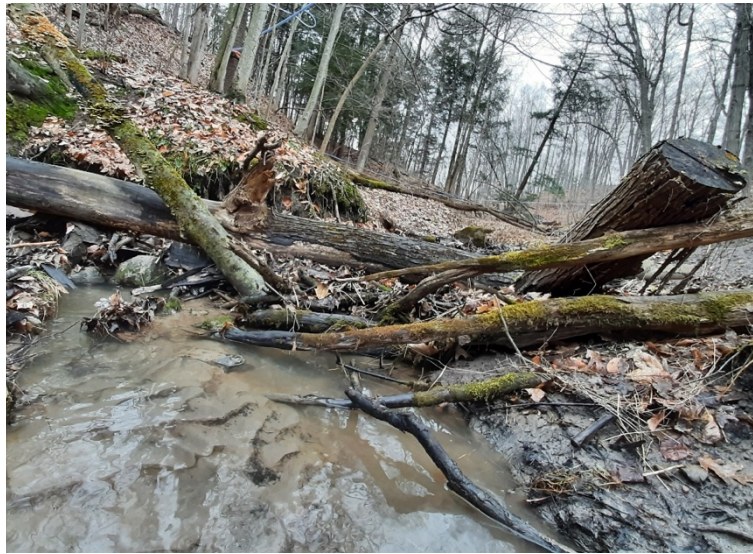
Name:	RT1
Priority level:	Major
Coordinates:	43.066070, -79.319055
Property/Nearest Location:	Agape Valley, 392 Kilman Rd Pelham ON
Barrier Description:	Fallen logs, branches, leaf litter

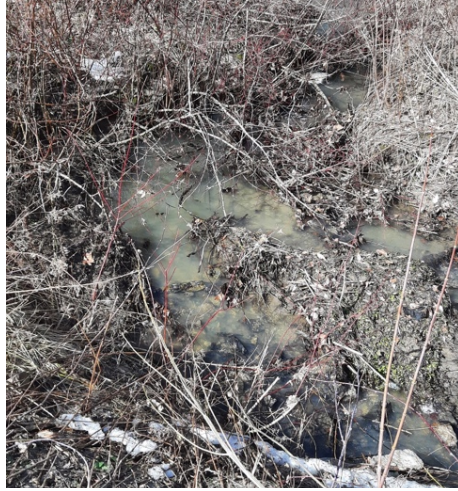
Name:	Effingham1
Priority level:	Minor
Coordinates:	43.0741641, -79.3082019
Property/Nearest Location:	2145 Effingham St Pelham ON
Barrier Description:	Blocked by sediment and dense thickets.

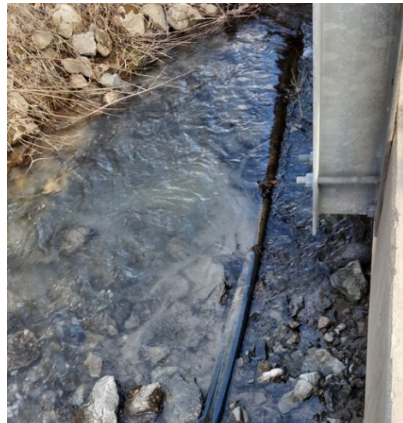
Name:	Effingham2
Priority level:	Minor
Coordinates:	43.0736586, -79.3085928
Property/Nearest Location:	2135 Effingham St Pelham ON
Barrier Description:	Thick cable or pipe crosses the creek causing a small waterfall.

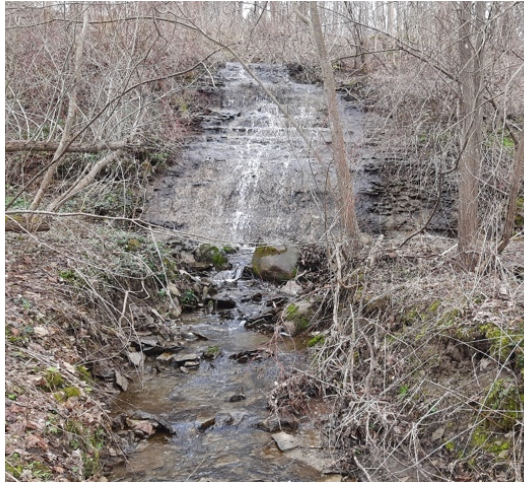
Name:	Luffman1
Priority level:	Major
Coordinates:	43.0753066, -79.3060772
Property/Nearest Location:	224 Luffman Dr Pelham ON
Barrier Description:	Large, natural waterfall. North side of road.

For any natural barrier that is comprised of dead vegetation and/or sediment build up, those need to be removed slowly and carefully, so only small amounts of sediment at a time are allowed to carry on downstream. The large waterfall is completely impassable and that will not change. There is an alternate route though. On the opposite side of Luffman Road where the

waterfall is, there is another possible route for the fish, but that also has a barrier in the way. That barrier is natural, and it can be easily removed.

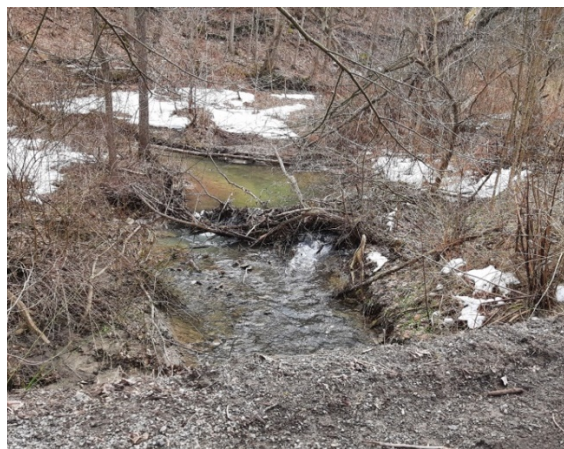
Name:	Luffman2
Priority level:	Major
Coordinates:	43.0753066, -79.3060772
Property/Nearest Location:	224 Luffman Dr Pelham ON
Barrier Description:	Debris build up, fallen branches. South side of road.

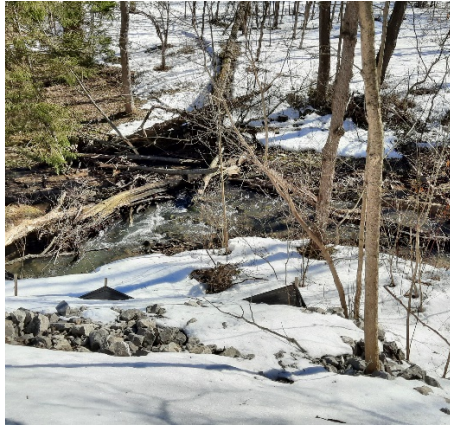
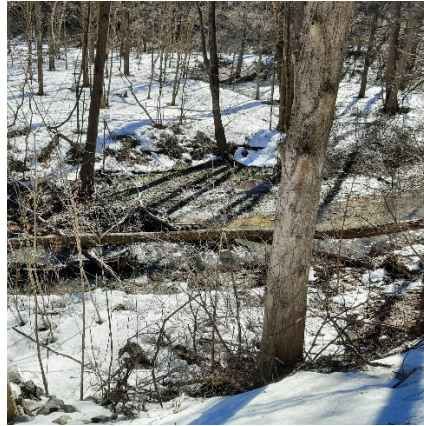
Name:	SulphurSpring1
Priority level:	Major
Coordinates:	43.0762823, -79.3064685
Property/Nearest Location:	2150 Sulphur Spring Dr Pelham ON
Barrier Description:	Numerous fallen trees

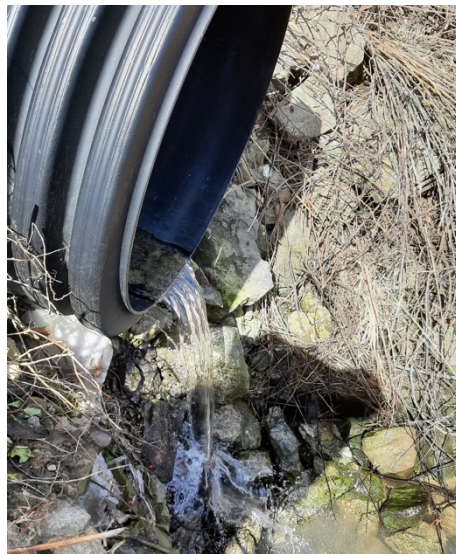
Name:	Roland1
Priority level:	Major
Coordinates:	43.0892011, -79.3005864
Property/Nearest Location:	180 Roland Rd Pelham ON
Barrier Description:	Raised culvert causing a waterfall

The culverts present more of a complex problem as they are built into the road. They could be re-engineered so that they're slanted downwards, but that would require tearing up the road at various points and it would be prohibitively expensive. Instead, step-pool systems up to the culverts could be constructed with small steps, so the fish could carry on upstream (Wang & Yu, 2007).

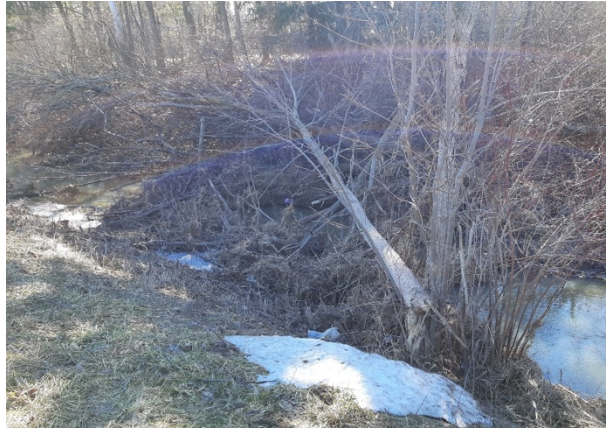
Name:	Roland2
Priority level:	Major
Coordinates:	43.089690, -79.319535
Property/Nearest Location:	340 Roland Rd Pelham ON
Barrier Description:	Fallen branches, fallen tree, overgrown grass

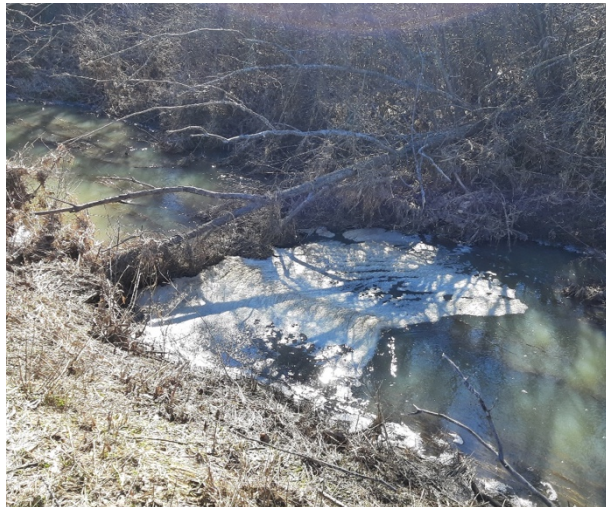
Name:	Roland3
Priority level:	Major
Coordinates:	43.0896793, -79.3198946
Property/Nearest Location:	346 Roland Rd Pelham ON
Barrier Description:	Fallen branch, overgrown grass

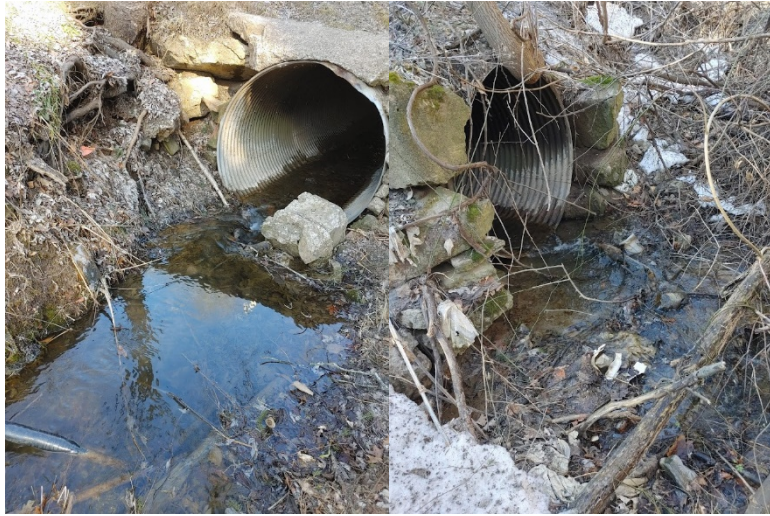
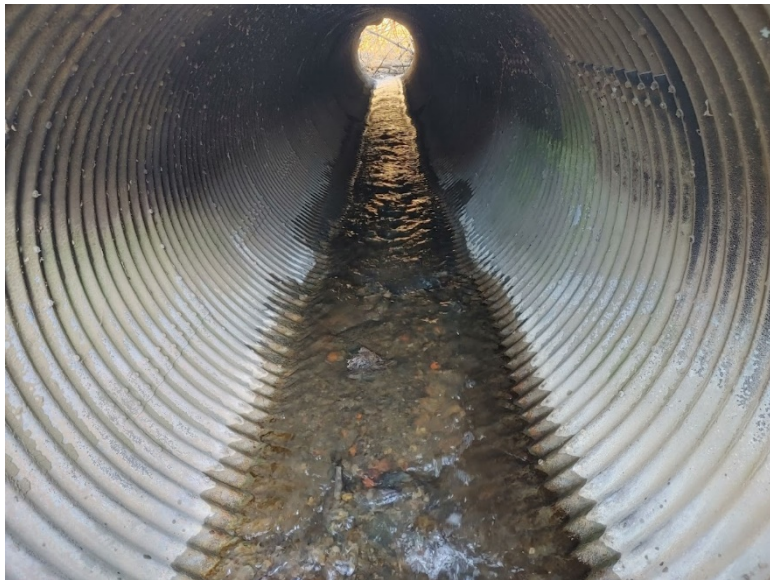
Name	Metler1
Priority level	Minor
Coordinates	43.0613650, -79.3272597
Property/Nearest Location	480A Metler Rd Pelham ON
Barrier Description	Debris and sand build up inside of the culvert

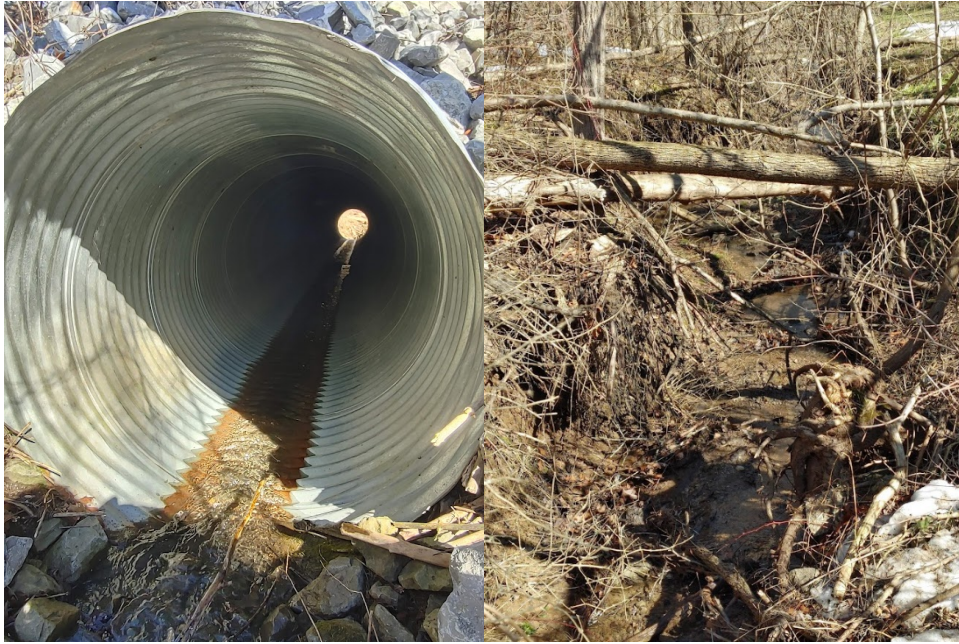
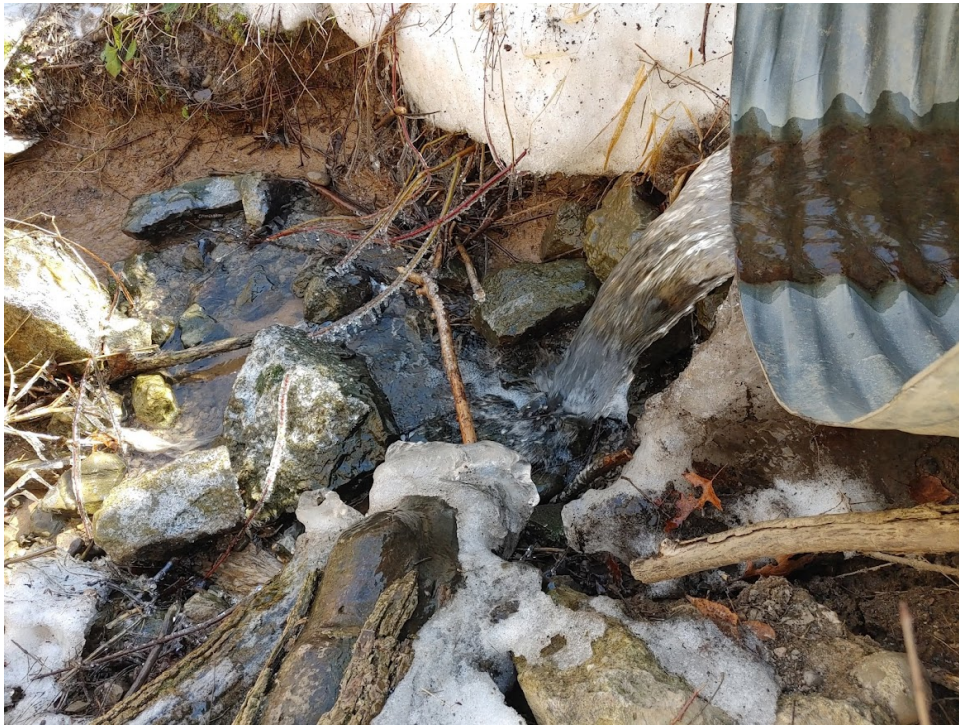
Name	Metler2
Priority level	Minor
Coordinates	43.061967, -79.313521
Property/Nearest Location	329 Metler Rd (East of Effingham) Pelham ON
Barrier Description	The drain is high from the stream bed, creating a perched culvert

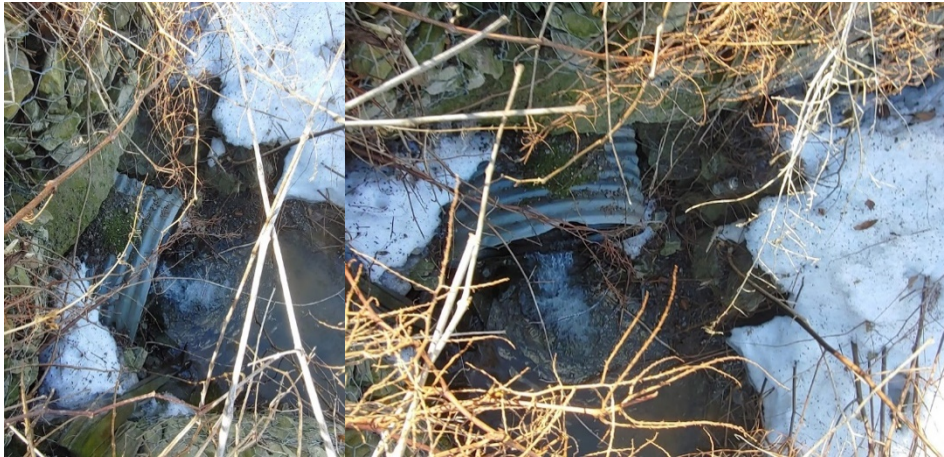
Name	Metler3
Priority level	Minor
Coordinates	43.0624085, -79.3131777
Property/Nearest Location	203-299 Metler Rd Pelham ON
Barrier Description	A small waterfall. However, the water flow only operates in the spring, according to a nearby landowner.

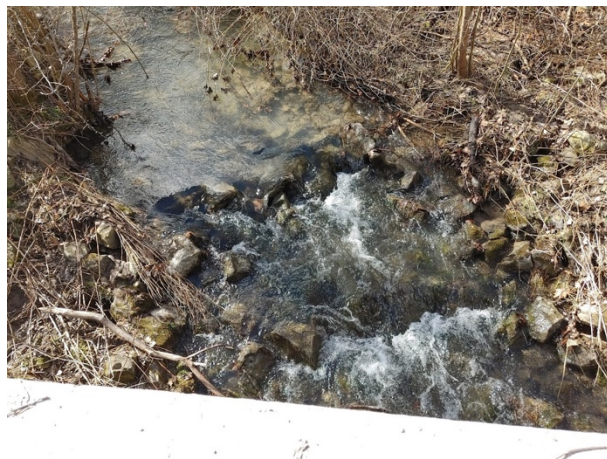
Name	Kilman l
Priority level	Minor
Coordinates	43.071919, -79.313984
Property/Nearest Location	Bridge. Kilman Rd Pelham ON
Barrier Description	A pebble barrier that connects with the bridge.
