## **Concept Plans to Re-construct the Amphibian Pond at Malcolmson Eco-Park into Functioning Vernal Pools**

Submitted to fulfill the requirements of the term project for Ecosystem Restoration (ENVR 9147) at Niagara College, 2021.

Names: Louise Clements, Taylor Hamel, Alex Posteraro,  
Ameera Saleh, Robert Teodorini, Marek Toporowski  
Date: 6 December 2021

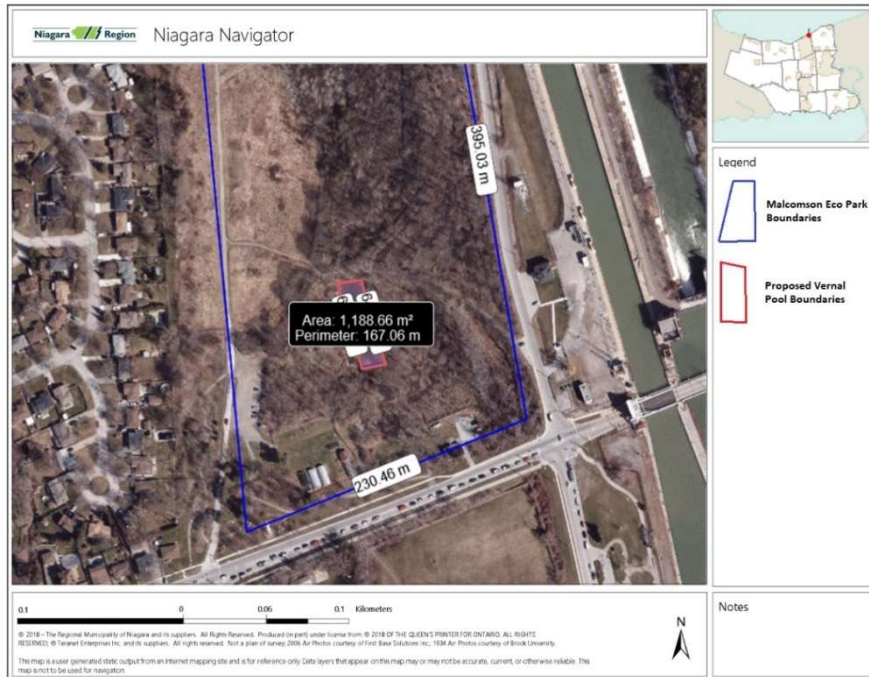
Figure 1: Malcomson Eco-Park and Amphibian Wetland Site Boundaries. Created using Niagara Navigator, 2021.

Malcolmson Eco-Park is a 14-hectare public park in the north side of St. Catharine's, Ontario (Figure 1). The site, west of Welland Canal and East of Lake Ontario, was historically used as a construction ground in the early 1900's during the construction of the Welland Canal (Wilson, 2002). Today, the park is used as a natural education center for the public to enjoy themselves and to learn about the natural landscape. The park and has a unique design which divides it into different community types to promote education on ecosystem diversity. The land surrounding the park includes residential areas, the Welland Canal, and a wastewater treatment plant.

Several site visits were conducted in order to assess current site conditions and surrounding areas and assess community health and threats. The site itself is approximately 1017.63m<sup>3</sup> (Figure 1). Upon inspection of the site, a few prominent features were identified. It is an area with low canopy cover (>20%) and contains the remnants of an Amphibian Pond, including a large depression which is absent of water. The soil is unable to hold water for a long enough time frame for amphibian species to successfully reproduce and will therefore require to be amended. There is an existing weir on the site that has sustained some damage, as well as a piezometer which is not functional and will need to be removed. There is a considerable amount of leaf litter present at the site, as well as some existing deadfall logs that can be used as adult amphibian habitat. Vegetation is growing within the depression area due to the absence of water. There are also several button bushes plants which were seemingly abandoned in the site or possibly have been upturned from the soil frost heave. Specific plants within the site have been recorded in detail in Section 4.0, Site Inventory.

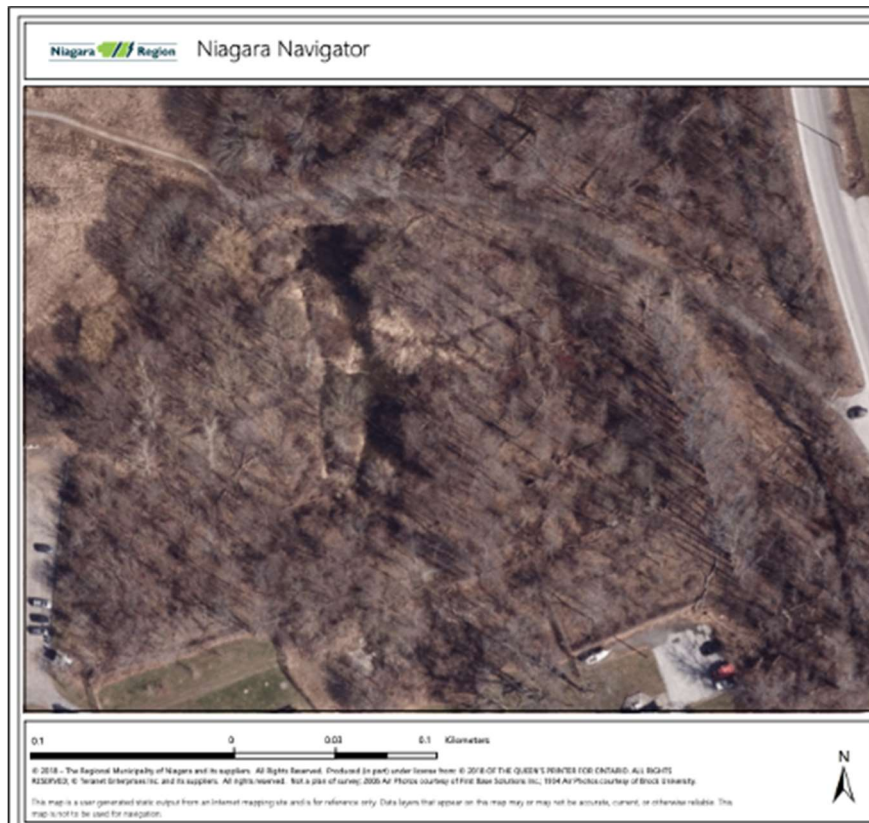
Figure 2: Amphibian Wetland at Malcomson Park 2018. Created using Niagara Navigator, 2021.

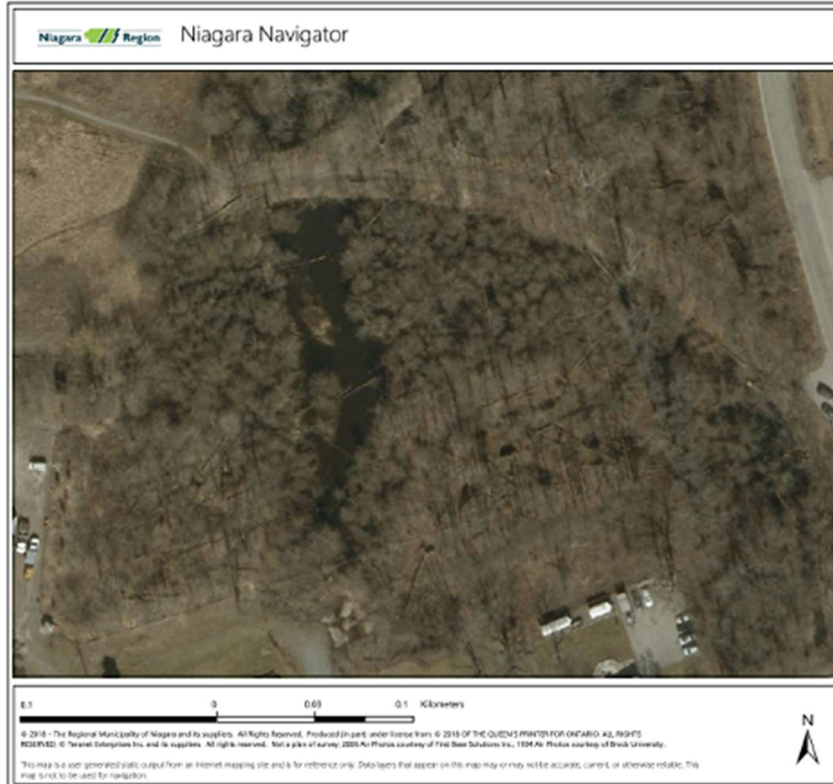
Figure 3: Amphibian Wetland at Malcolmson Park, 2010. Created using Niagara Navigator, 2021.

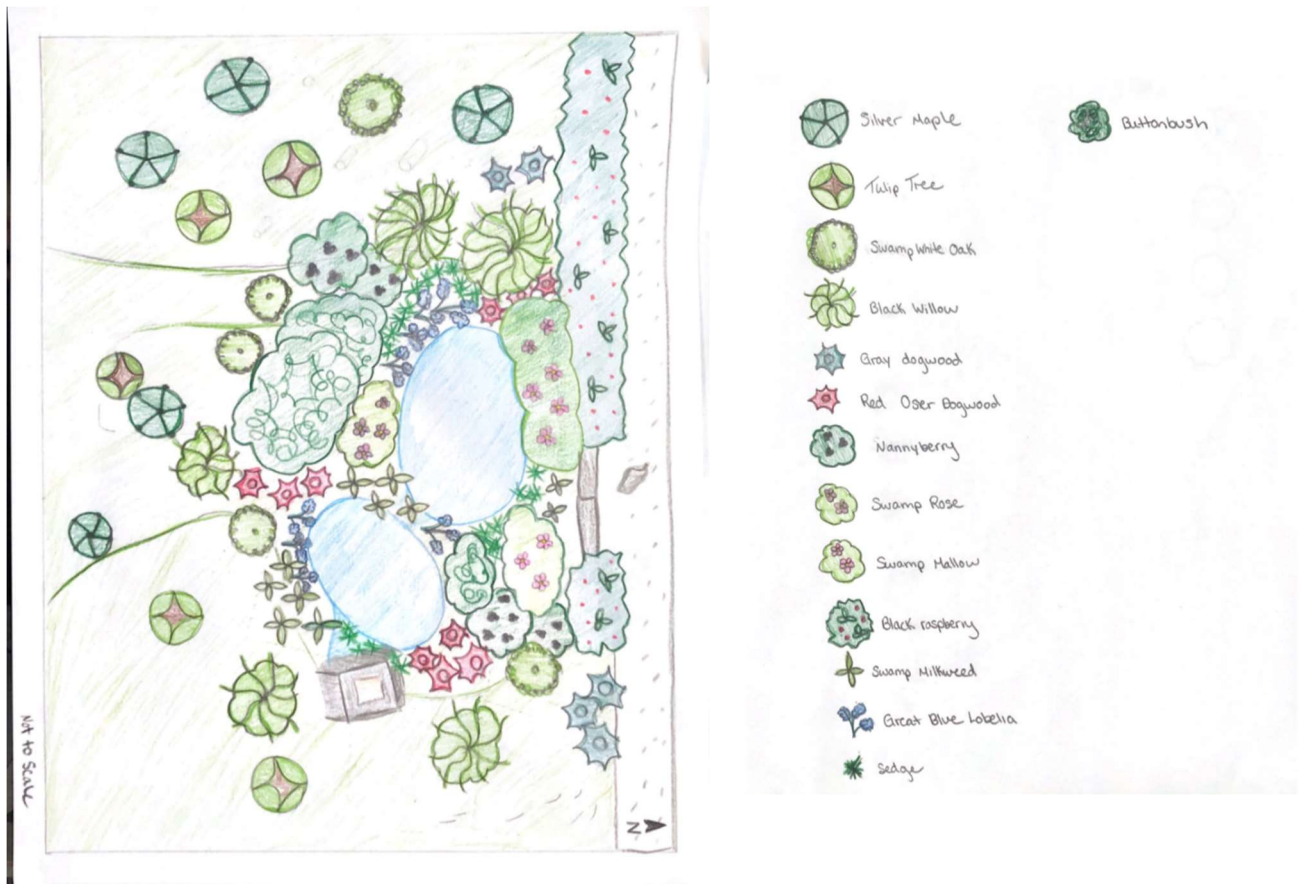
Figure 9: Proposed Planting Plan

A low abundance of plants will be located within the vernal pool itself, and focus will be placed on planting in the areas surrounding the proposed vernal pool to provide shade and sources of refuge and leaf litter used by vernal pool animal species (Calhoun et al., 2014). Table 7 outlines the proposed planting list. All these plants can be sourced from Verbinnen's Nursery Ltd (Verbinnen's Nursery Ltd, 2021). Some plants can be found on-site at Malcomson park as well and can either be transplanted to better locations or used to create cuttings to place where they are needed. A detailed planting map can be found in Figure 9.
