Water Quality Report

Six Mile Creek and Kraft Drain

Friends of Fort Erie's Creeks

June 2019 - August 2019

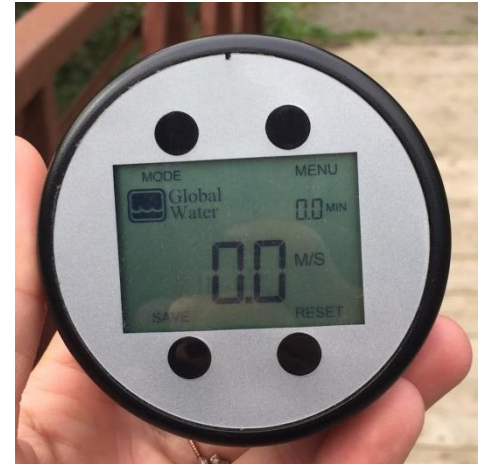
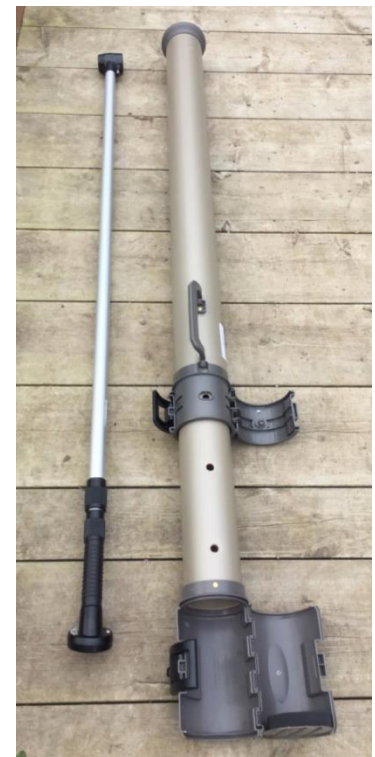
Figure 4: Flow Probe

Figure 5: Flow Probe

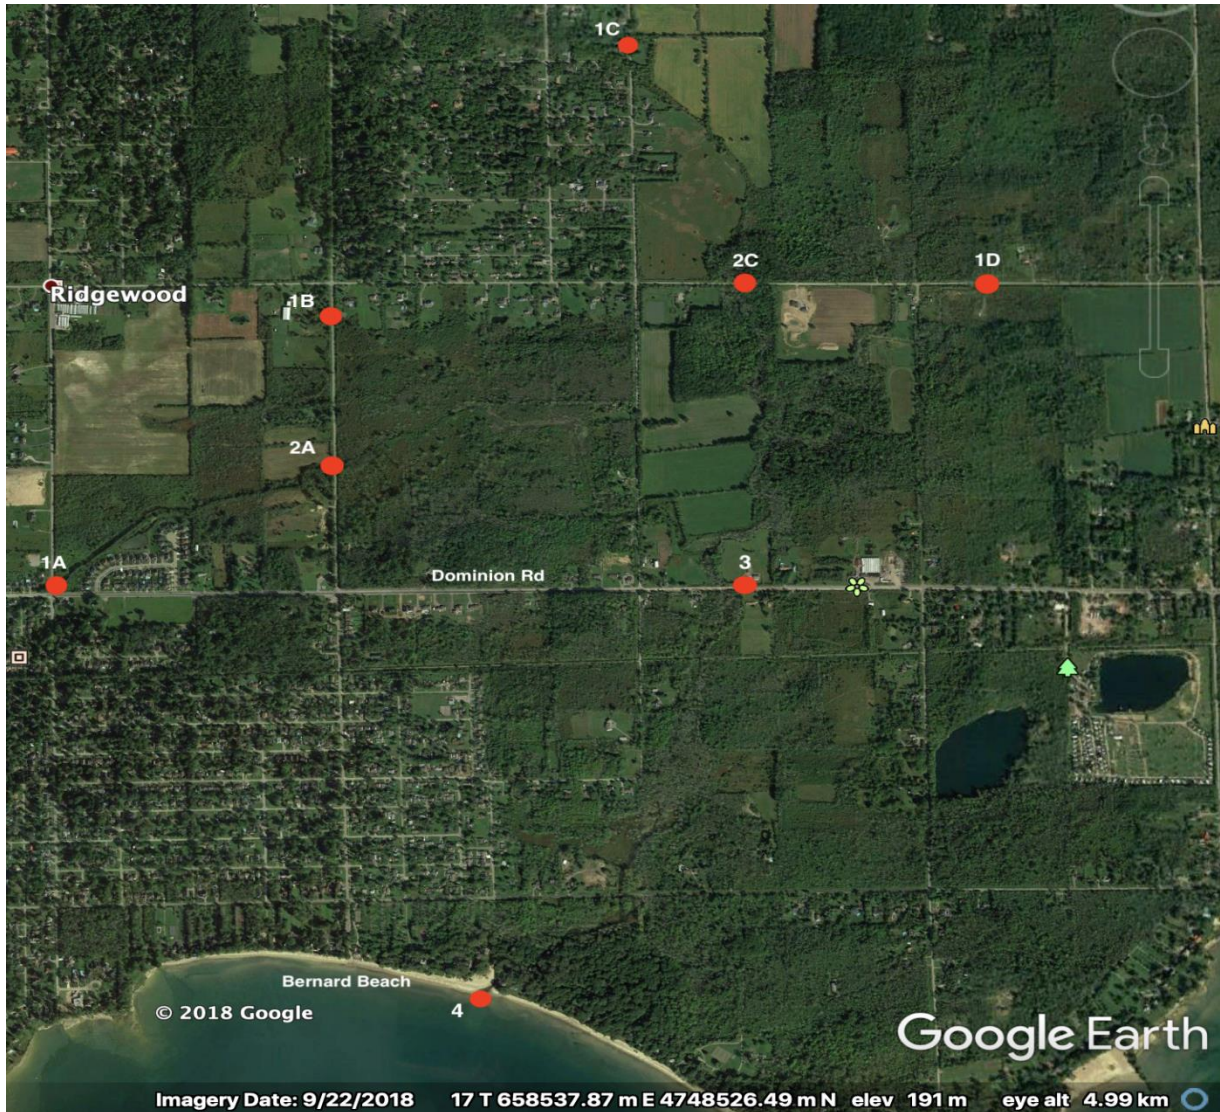
Figure 6: Map of Six Mile Creek

Figure 6 shows a map of Six Mile Creek with the sample sites labeled. These sites are 1A, 1B, 1C, 1D, 2A, 2C, 3, 4. These sites were labeled specifically depending on where they are located within the tributaries. If labeled with a 1 this means they are the start of a new tributary, if labeled with a 2 and a corresponding letter matching the number 1 tributary this means the site is further down the tributary. For example, 1A and 2A are the same tributary but 2A is further down the tributary at a new road intersect. Site 3 is where all the tributaries meet and site 4 is where the creek meets Lake Erie.

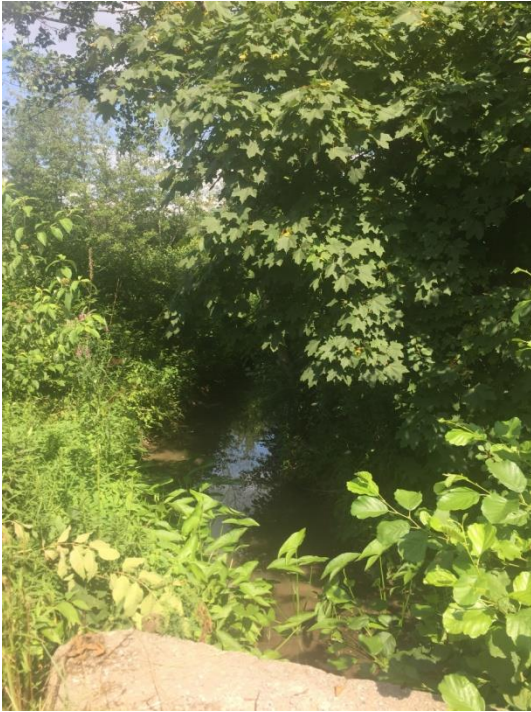
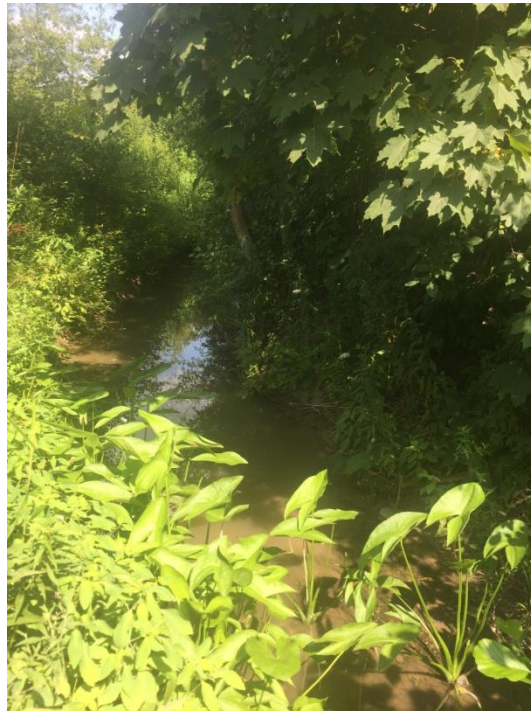
Site 1A is located on Burleigh Road adjacent to Shagbark Nature Park. This site is the beginning of a new tributary.

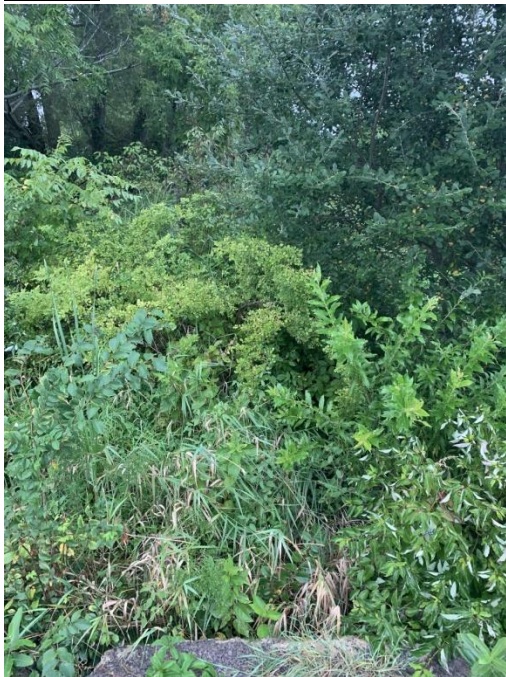
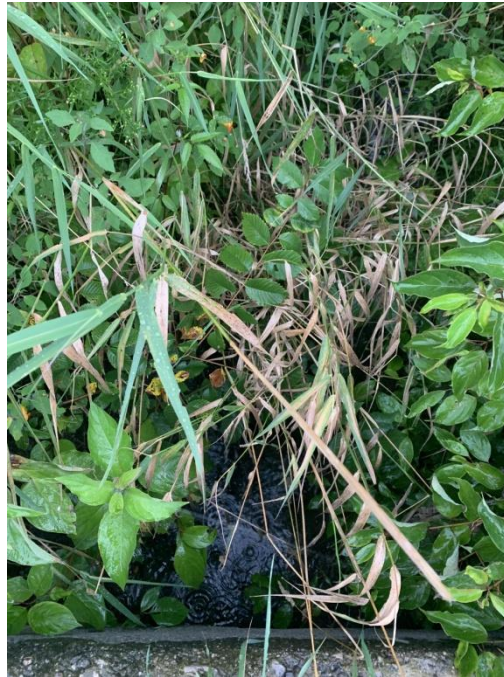
Site 1B is located on Bernard Ave near the intersection of Bernard and Nigh Road. This site is the beginning of a new tributary.

Site 1B is located on Bernard Avenue by the intersection of Bernard and Nigh Road, as is shown in Figure 9 and Figure 10. The results for this site were mostly below the recommended limit of 0.05mg/L. Other than the normal range of 0.02mg/L to 0.04mg/L the levels were seen to be increased during the week of June 25th, July 17th and very slightly July 18th. The reasons for the increased values are unknown. It was noted that there was construction being done on Dominion Road during the week of June 25th at site 3, but this is unlikely to be the cause as the other sample sites had not increased during this time.

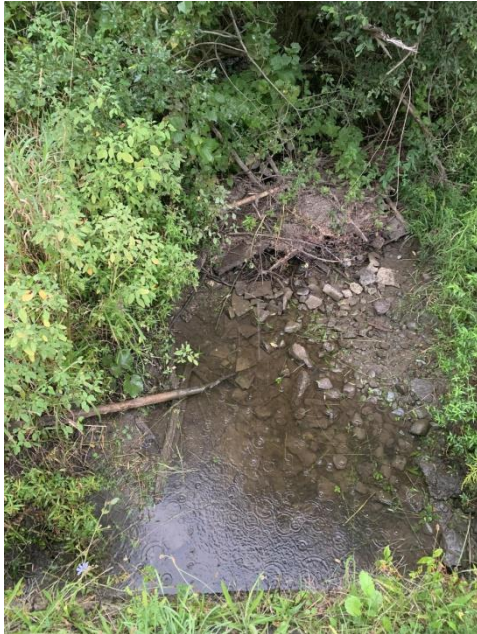
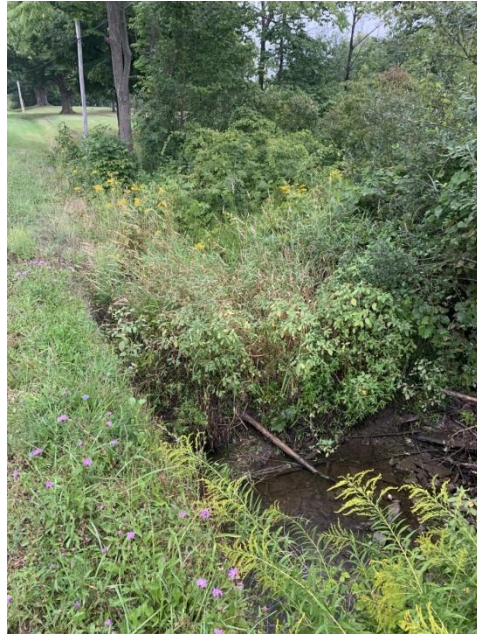
Site 1C is located on Centralia Avenue N beside a cemetery. This site is the beginning of a new tributary.

Site 1C can be found south of the cemetery on Centralia Avenue North, as seen in Figure 11 and Figure 12. Photographs of the cemetery can be found in the Appendices section. Throughout the sampling period, the results were found to be between 0.24 mg/L to 1.27 mg/L other than a low reading during the spring melt of 0.09mg/L. This sight had no specific reasons why the phosphate readings were above guidelines, but the surrounding land use may reveal an answer.

Site 1C is near some residences with a couple swimming pools, farmland and a small, inactive cemetery, the Hershey Cemetery, which can be traced back to the 19th century (Hershey Cemetery Records, n.d.). The phosphate levels range from 0.09 - 3.2 mg/L and nitrates were recorded at 2.11 mg/L. The residences and farmland would have the typical possible sources of phosphates and nitrates, like personal hygiene products, fertilizer, pesticides and herbicides. Beyond that, the cemetery is also a possible source. Photographs of the cemetery can be found in the Appendices section. The headstones seem to be made from limestone and granite. As stated above, limestone has 1560 PPM of phosphates (Porder and Ramachandran, 2012) and 20 - 300 PPM of nitrates (in the green claystone, specifically) (Holloway and Dahlgreen 2002). No similar information is available on the other colours of limestone. For granite, the average amount of phosphates is 568 PPM (Porder and Ramachandran 2012) and the range of nitrates is 1 - 243 PPM (Holloway and Dahlgreen 2002). The land is also slanted towards the south east and the water flows through wooded areas, which helps to remediate the water as much as possible.

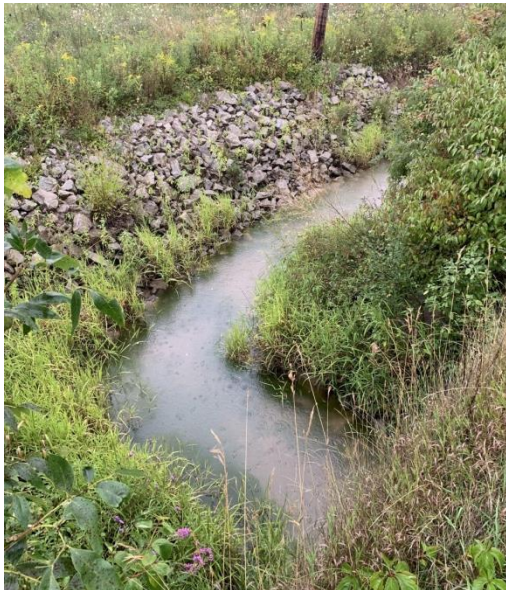
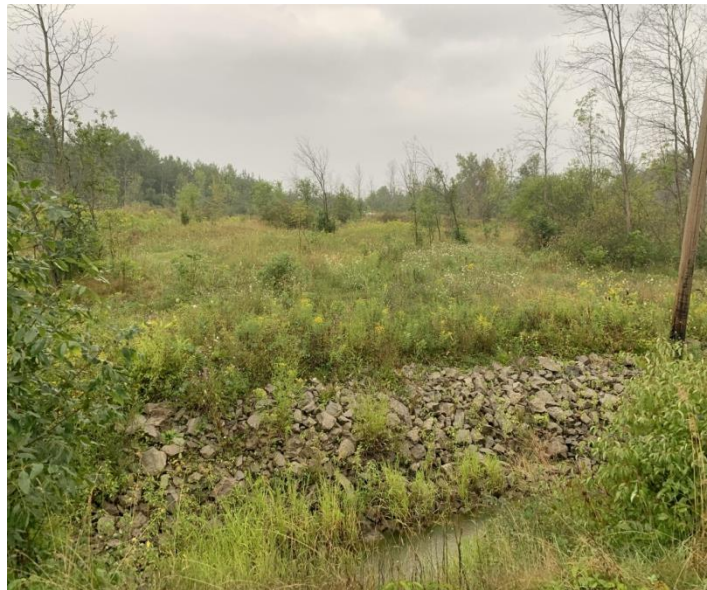
Figure 13: *Site 1D (Six Mile Creek)*

Figure 14: *Site 1D (Six Mile Creek)*

Site 1D is located on Nigh Road. This is the beginning of a new tributary which runs parallel to Nigh Road.

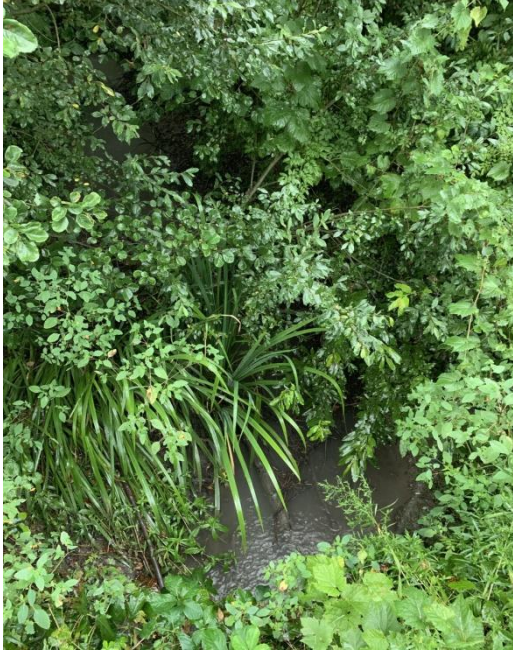
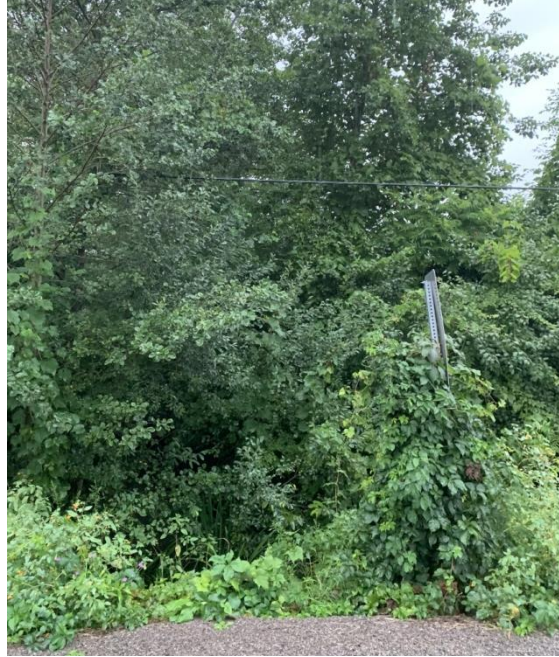
Site 2A is located on Bernard Avenue and is the second sample site to tributary 1A.

Site 2A can be found on Bernard Avenue, south of site 1B, which is shown in Figure 15 and Figure 16. The results seemed to fluctuate between <0 and 1.2 mg/L, peaking at the end of July to 2.1 mg/L. This site is further down the tributary from site 1A, it can be seen in the graph above (Fig 33) that as site 1As values would fluctuate higher and lower, as would 2A.

Site 2A is surrounded mainly by farmland, forests, some residences and a couple swimming pools. The land in this specific area is also slanted to the east and north east. Phosphate levels range from too low to be readable - 1.2 mg/L and nitrates were measured at 0.33 mg/L. Possible sources would be decaying plant matter, personal hygiene products, fertilizer, pesticides and herbicides. The wooded areas would be remediating a lot of the nutrients.

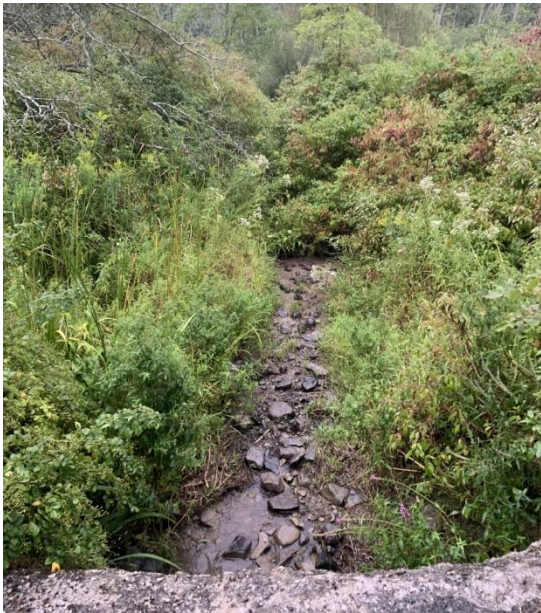
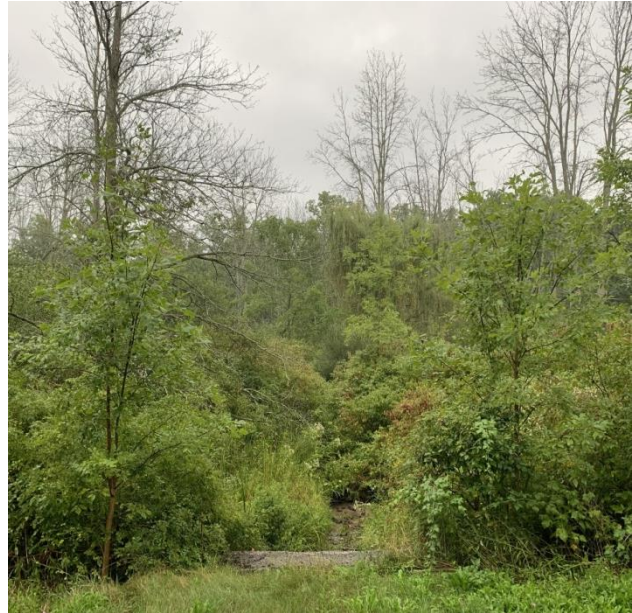
Figure 17: Site 2C (Six Mile Creek)

Figure 18: Site 2C (Six Mile Creek)

Site 2C is located on Nigh Road and is the second sample site to tributary 2A.

Site 2C can be found on Nigh Rd east of Centralia Road. The results of this site show the phosphate levels to peak from the spring melt up to 1.68 mg/L in the first week of sampling. The normal range for this site was between 0.57 mg/L and 0.83 mg/L.

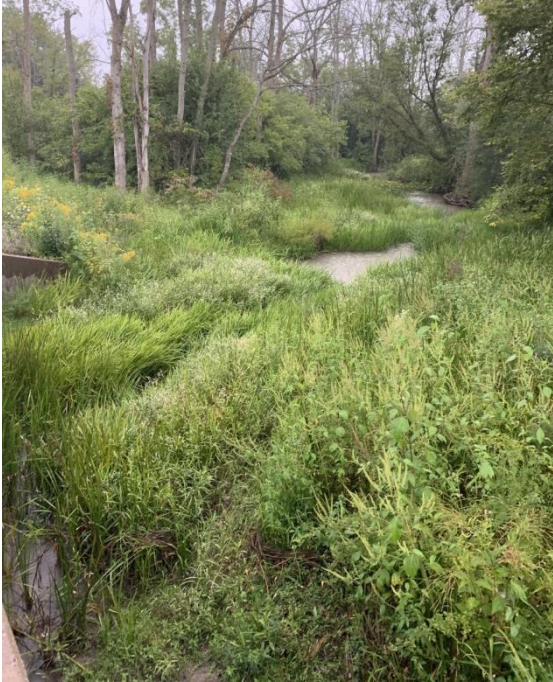
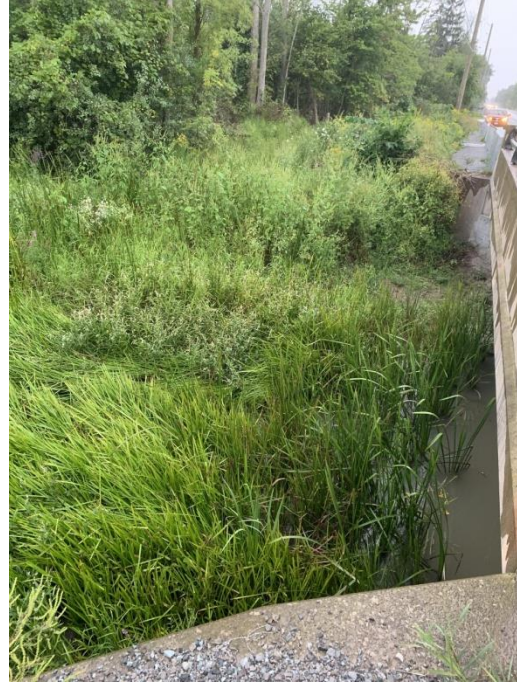
Figure 19: Site 3 (Six Mile Creek)

Figure 20: Site 3 (Six Mile Creek)

Site 3 is located on Dominion Road and runs directly underneath an overpass. This site is also located adjacent to Sex Smith Farms.

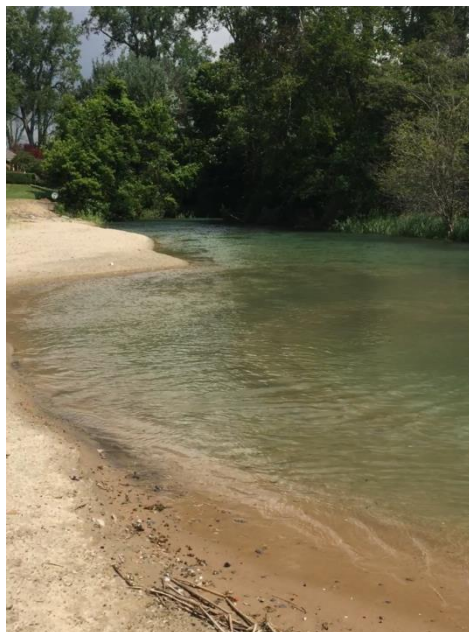
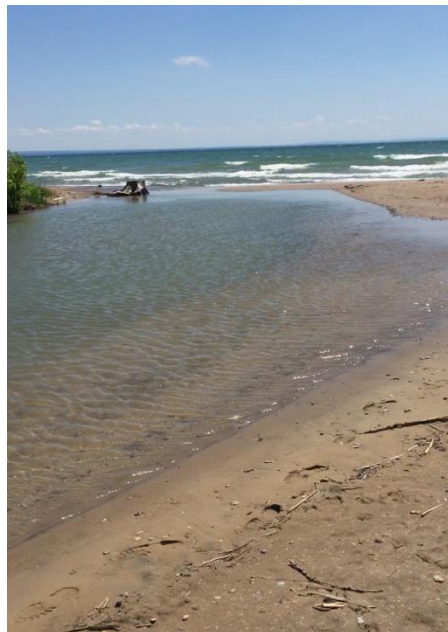
Figure 21: Site 4 (Six Mile Creek)

Figure 22: Site 4 (Six Mile Creek)

Site 4 is located at the end of Bernard Avenue at Bernard Beach. This site is where Six Mile Creek meets Lake Erie. This site is also where discharge readings were taken to determine the rate of phosphates being discharged into the lake.

Site 4 is on the east side of Bernard Beach, where Six Mile Creek drains out into Lake Erie, as is shown in Figure 29 and Figure 30. Samples were unable to be obtained during some of the weeks of sampling due to backflow from the lake into the creek giving false readings. For the weeks where there are results, the range was between 0.25 mg/L and 0.70 mg/L. The residential properties surrounding the end of the creek could be the result of high phosphate levels.

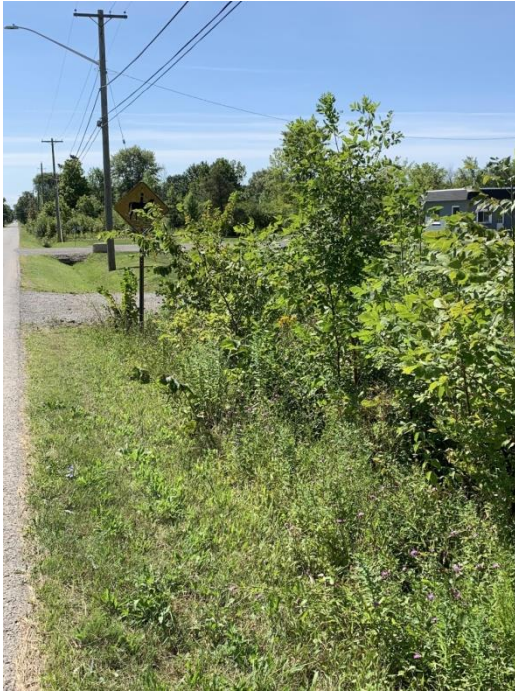
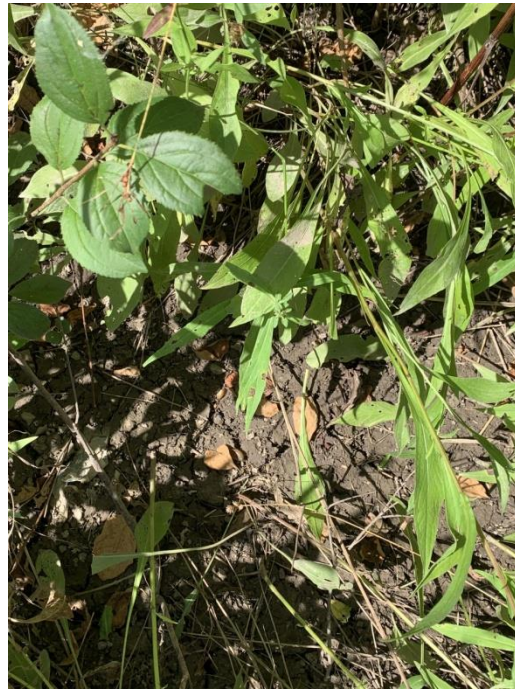
Site 1 is located on Kraft Road and is located on the left side of the road facing north. This site is located after the lawn care service when travelling on the road north.

As can be seen in Figure 24 and Figure 25, site 1 is located on the north end of Kraft Road, towards the intersection of Kraft Road and Garrison Road intersect. The results here were seen to be under 1 mg/L, with a range between 0.15 mg/L to 0.95 mg/L. It is also noted that samples from site 1 and 2, were only able to be obtained until the 25th of June as during the rest of the sampling period the sites were dry.

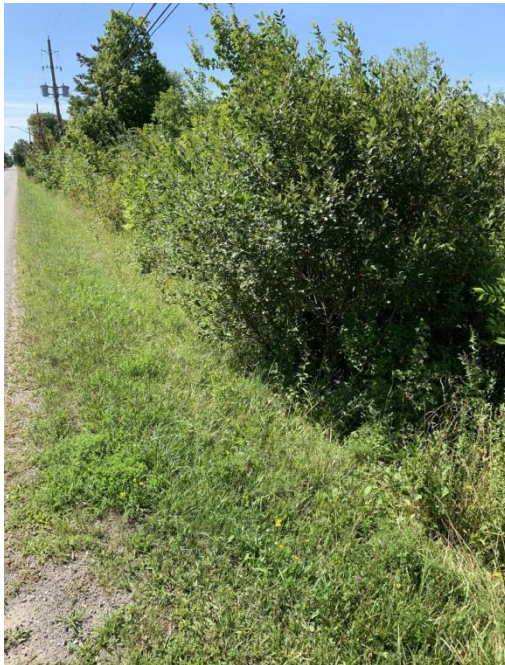
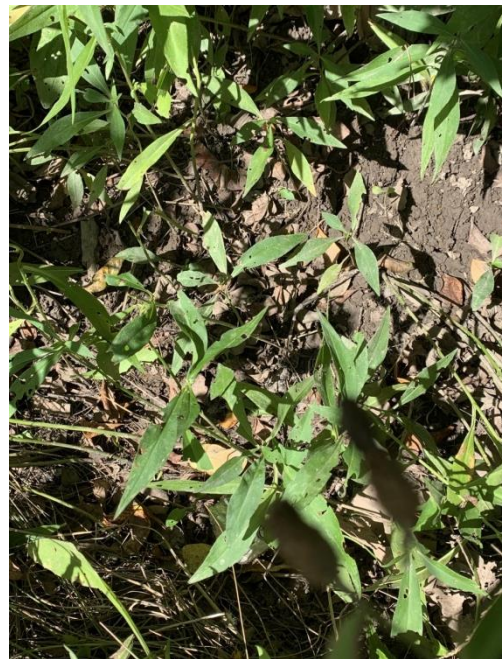
Site 2 is located on Kraft Road and is located on the left side of the road facing north. This site is located directly before the lawn care service when travelling on the road north.

Site 2 was located approximately 160 meters south of site 1, as seen in Figure 26 and Figure 27. The lowest reading at this site was 0.68 mg/L during the month of April, and the readings peaked at 1.13 mg/L on June 18th. After that, it declined to 0.24 mg/L on June 25th. A possible cause for the increase is the nearby landscaping business.

Site 2 is roughly 160 meters south of site 1 on Kraft Road. In addition to the school bus company, restaurant, car dealership, residences, and an open field (or farm land), the site is right beside a landscaping business. Land is slanted to the south. Phosphate levels ranged from 0.24 – 1.13 mg/L, but no samples could be taken to measure the nitrates as there was no runoff and the day the samples were being collected. Other than the common sources, another possible source would be decaying plant matter.

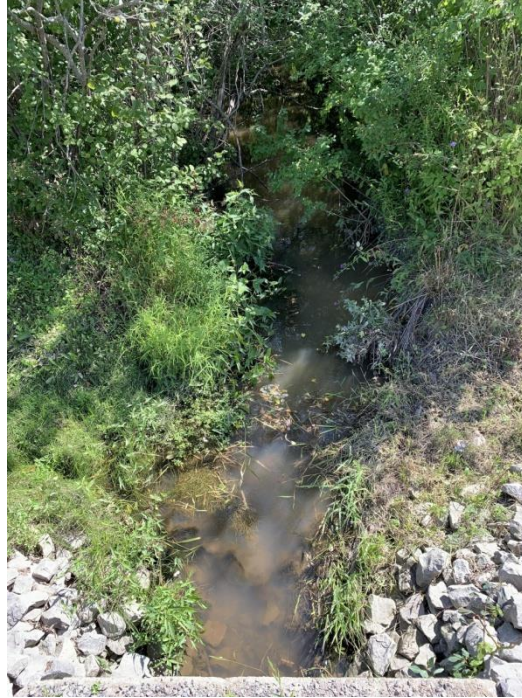
Figure 28: *Site 3 (Kraft Drain)*

Site 3 is located on Kraft Road and is located on the left side of the road facing north. This site is located adjacent to Kraft Road mailboxes and directly north of the road allowance.

Site 3 is the most southern site located on Kraft Road, as seen in Figure 28. Samples were able to be obtained here throughout the entire sampling time frame. All were recorded to be well below 1 mg/L, with the highest being at 0.66 mg/L. Site 3 is also where the road allowance began, from here on the drain flowed through the forested area.

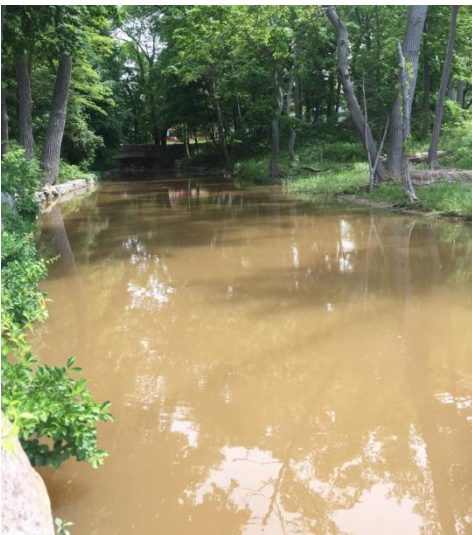
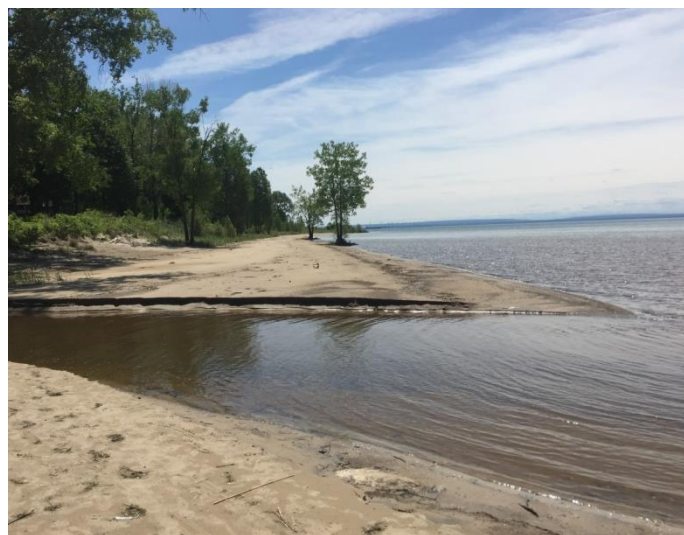
Figure 29: *Site 4 (Kraft Drain)*

Figure 30: *Site 4 (Kraft Drain)*

Site 4 is located at Crescent Beach at the end of Crescent Road. This site is where Kraft Drainage meets Lake Erie. This site is also where discharge readings were taken to determine the rate of phosphates being discharged into the lake.

As can be seen in Figure 29 and Figure 30, site 4 is located on the left side of the Crescent Park where the Kraft Drain connects to Lake Erie. The results here are usually very low, except for on July 8th. This was just after the long weekend for Independence Day and a lot of Americans own cottages along the beach. Some American products might have phosphates in them where the Canadian versions of those same products do not, like laundry and dishwasher detergents. So, if they buy those products in the US then bring them here to use, the phosphates could get into the water, thus causing the increase.

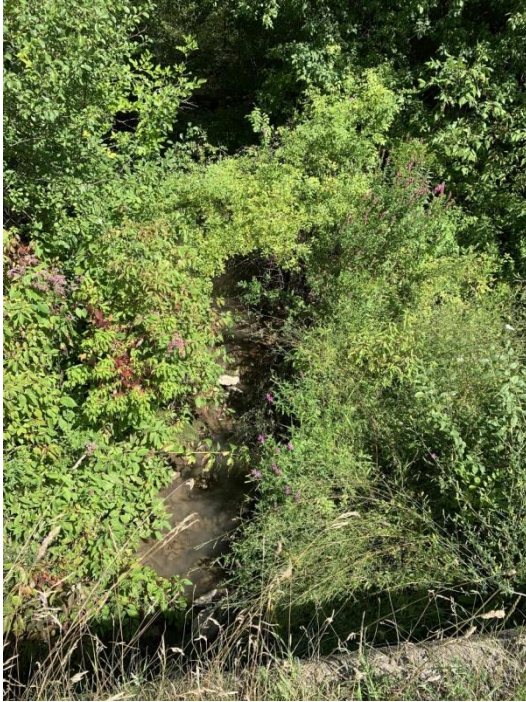
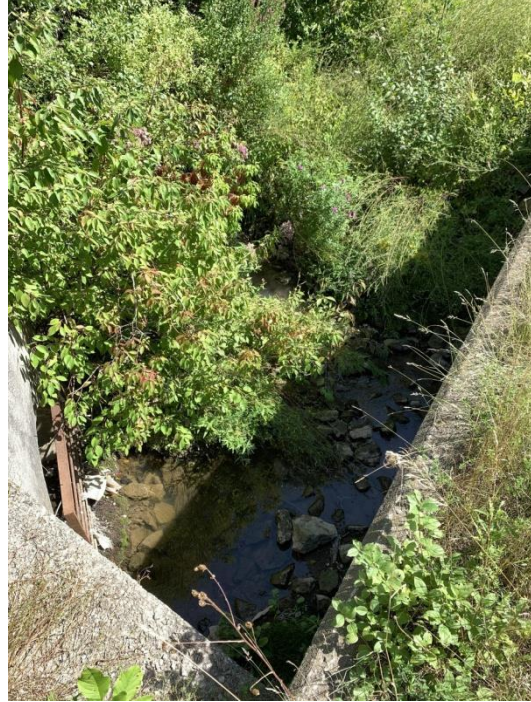
Site 5 is located on Dominion Road and is adjacent to the fire hall also located on Dominion Road. This site was added later into the sampling season.

Site 5 can be found on Dominion Road where the road allowance is going into Crescent Park, as shown in Figure 31 and Figure 32. Samples were retrieved four times from this site during the sampling time frame. The normal range was between 0.14mg/L and 0.39mg/L but had a large peak to 2.02mg/L on July 8th. The reason for the high peak was unknown.

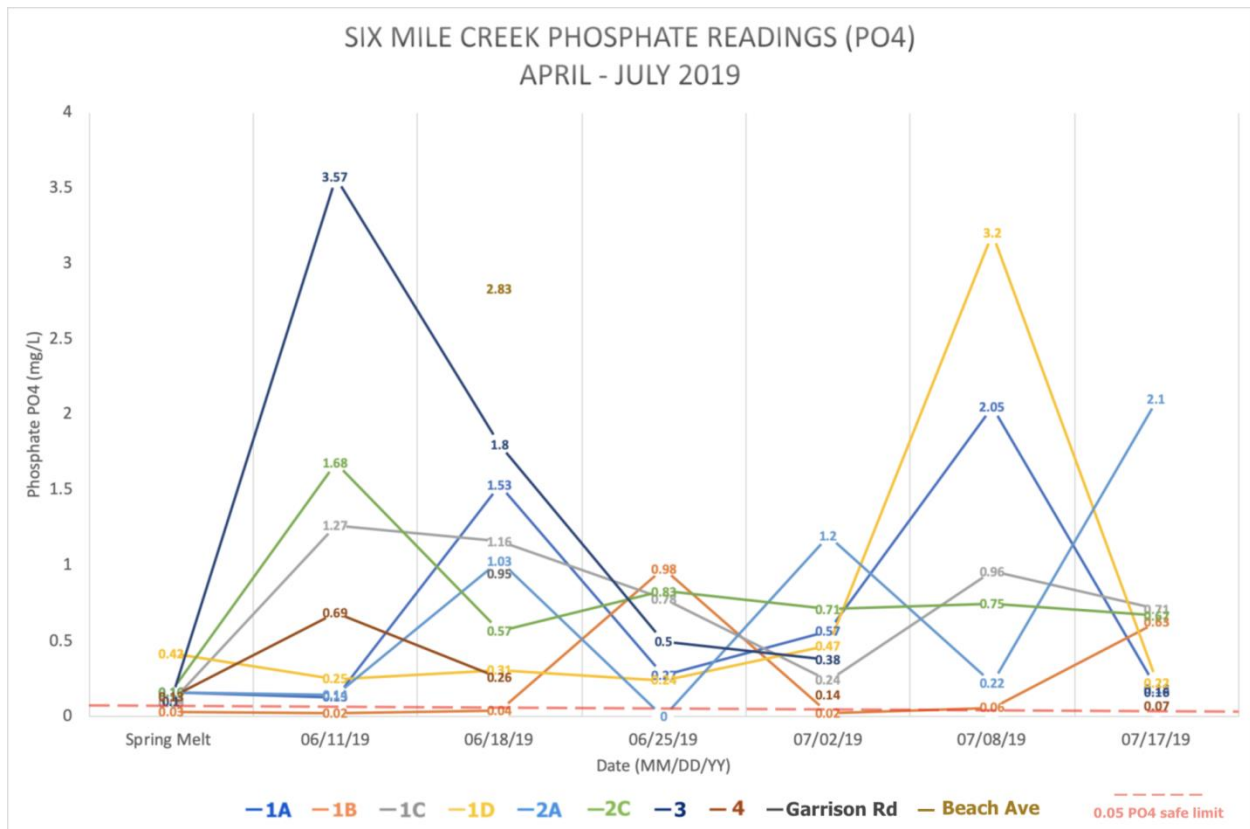
Figure 33: Six Mile Creek Phosphate Data

In Figure 33, we can see all the values of phosphate readings from Six Mile Creek over the study period from April until the end of July. In this graph we can see how the phosphates fluctuated over the course of the season. Generally reading this graph it can be seen that the phosphate levels were lowest during the spring melt and increased as it went into the first week of sampling during the month of June, the levels are seen to continuously fluctuate site to site with no significant relationship made between sites.

It can also be seen that sample site 1A, located on Burleigh Road off of Dominion Road, increased to 1.53mg/L in the 2nd week of sampling and again in the 5th week of sampling to 2.05. Reasons for this are unknown but it was observed that during the 2nd week of sampling (June 18) Dominion Road was being paved between Bernard Road and Burleigh Road. Due to run off from the construction this could be a reason the phosphates increased during this week. During the 5th week of sampling (July 8) it is believed that phosphates could potentially be high due the July 4th long weekend when American cottagers come to visit Fort Erie to use the local beaches and rent cottages along Lake Erie. Other than these peaks in phosphates 1A remained to have phosphate levels between 0.13mg/L and 0.57mg/L.

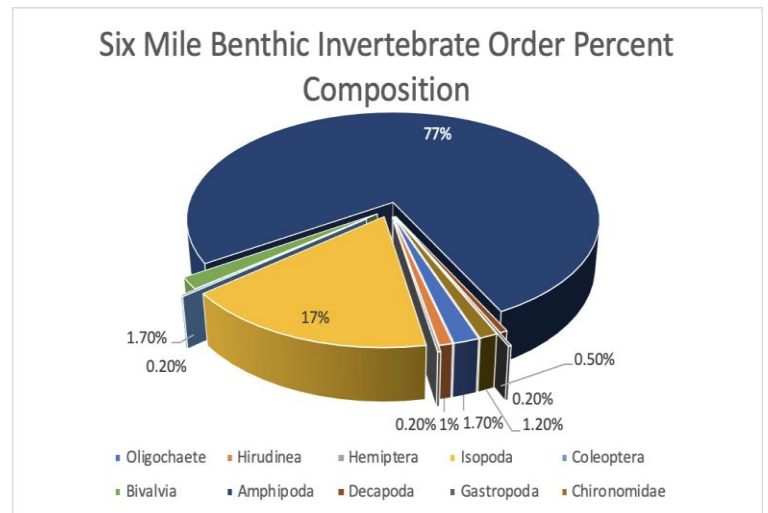
Figure 34: Six Mile Creek Percent Composition of Benthic Invertebrate Orders

Based on the information found in table 3, we can see that out of the total 415 specimens found they were divided into a total of 10 orders. Out of the 415 specimens found, 21% of the species were a high tolerant

species (can survive in poor water quality conditions), 79% of the species were a moderate tolerant species (can live in a wide range of water quality conditions) and 0% of the species were a low tolerant species (need to live in good water quality conditions). Looking at these results, we can see that the water quality condition is average based on organic pollution. This provides habitat for a variety of benthic macroinvertebrates that have a moderate to high tolerance to pollution based on 100% of indicator species being moderate to high tolerance species (Bouchard, 2004).

Based on the UPS Classification (University of Puget Sound) it states that if the stream has a total number of orders < 8, then the stream conditions are considered poor. If the stream has a total number of orders between 8 and 15 then the stream conditions are considered moderate, and if > 15 than the stream conditions are considered good. When looking at the data collected, in table 3, we can see that a total of 10 orders were counted, making Six Mile Creek considered to have moderate stream conditions.

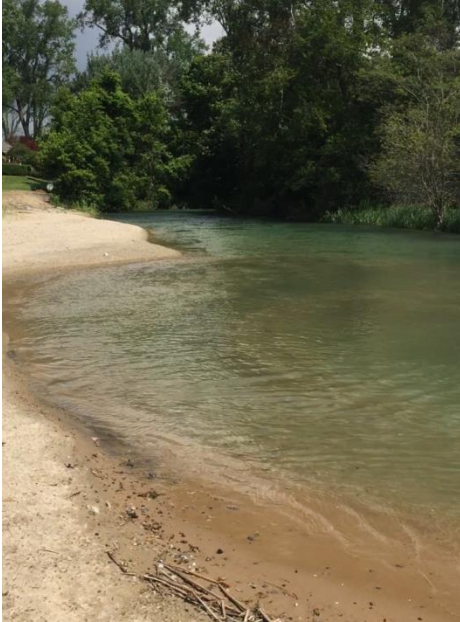
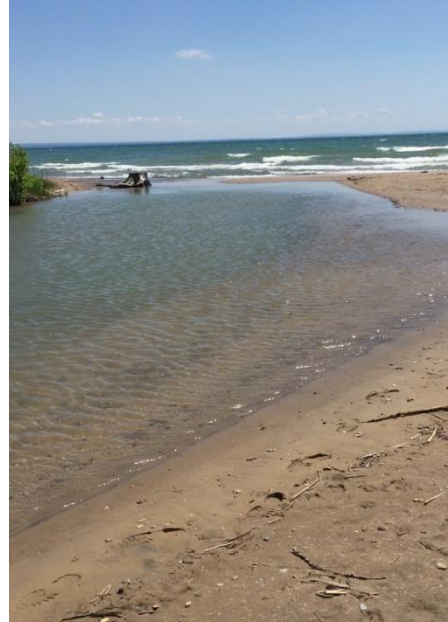
Flow readings were taken at the mouth of Six Mile Creek at Bernard Beach (site 4), where it connects with Lake Erie. Flow data is based on 3 days readings were taken for our small study. Phosphate readings were taken 5 times at the same location, including once right after the spring thaw. This data can be used to look at how much total phosphorus may be loading into Lake Erie. Below are charts recreated from flow data taken at Bernard Beach.

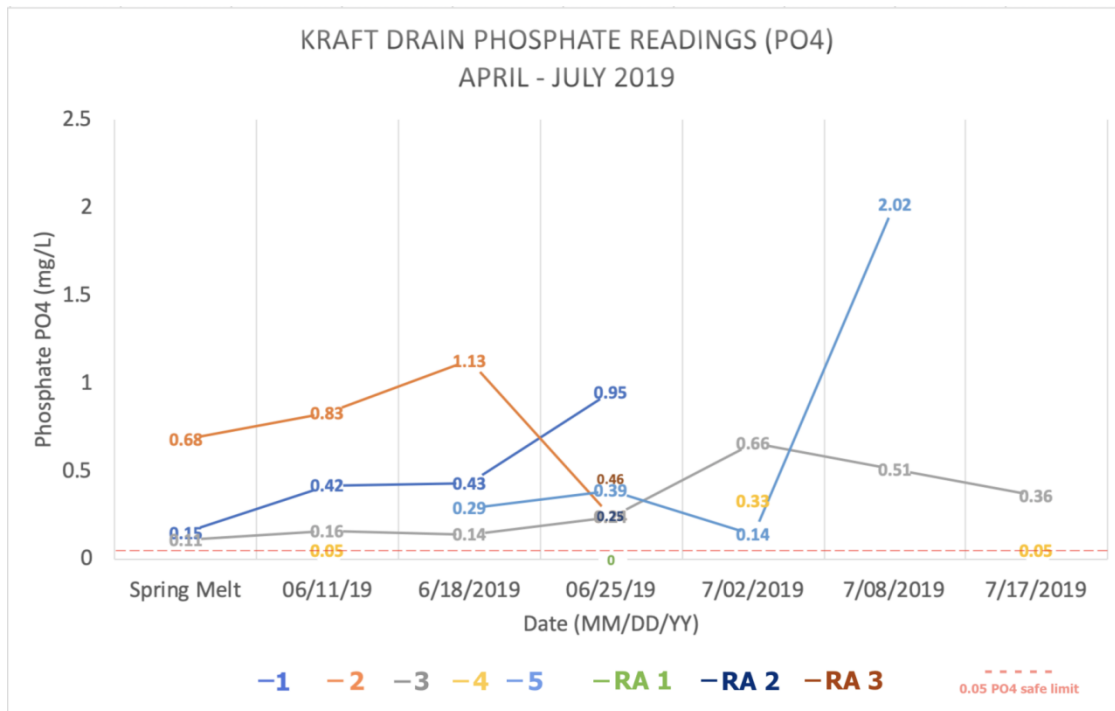
Figure 37: Kraft Drain Phosphate Data

In Figure 37, we can see all the values of phosphate readings from Kraft Drain over the study period from April until the end of July. Generally reading this graph it can be seen that all sites, excluding the beach site, were well over the safe limit of 0.05mg/L. Though the results show high readings, for site 1 and 2, at the beginning of the season, we were unable to attain samples after the date of June 25th as these sites were completely dry. It can be seen that the phosphate levels had no significant relationship made between sites.

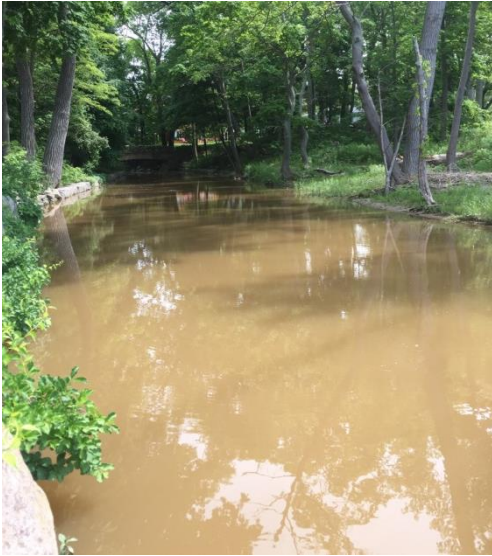
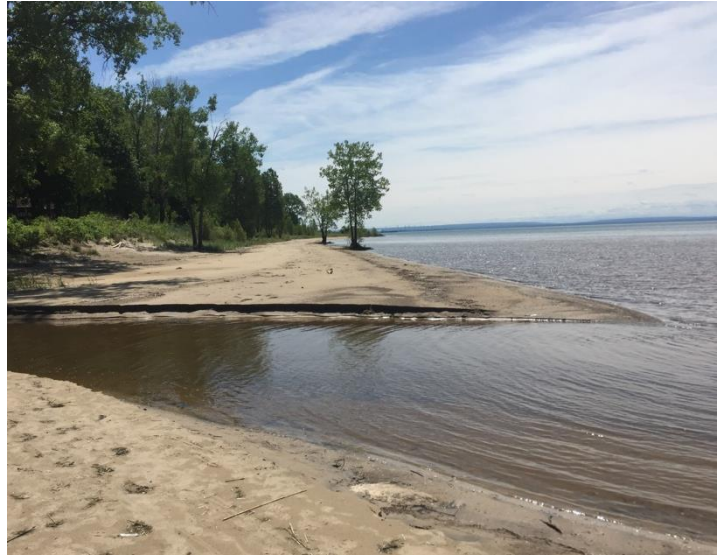
Flow readings were taken at the mouth of the Kraft Drain at Crescent Beach, where it connects with Lake Erie. Flow data is based on 4 days readings were taken for our small study. Phosphate readings were taken 3 times at the same location. This data can be used to look at how much total phosphorus may be loading into Lake Erie. Below are charts recreated from flow data taken at Crescent Beach.
