A Water & Soil Quality Report of 13145 Lundy's Lane

Robert Teodorini

Renee Delaney, Small Scale farms, Katie Altoft, and Niagara College

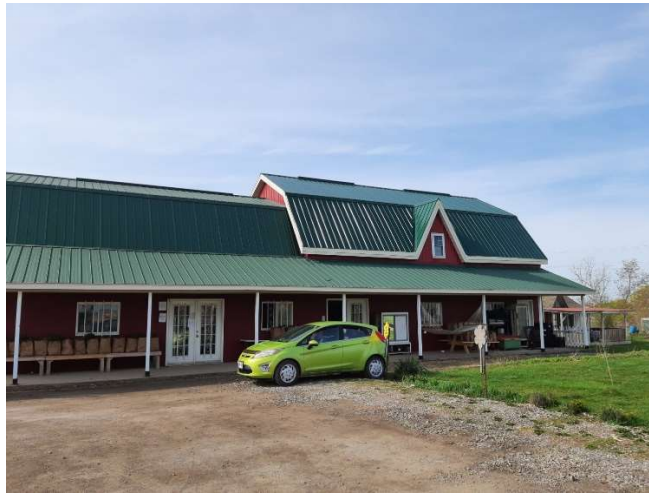
Figure 1: The main hub building

The first two sets of results were taken from the sinks in the work area and the bathroom of the main hub building. As the water samples from the main building comes from the well, the results are compared against drinking water standards as the source provides potable water. There is no filter for the water to run through as it comes into the main building though, but as that water is only for washing hands, bins, etc., it's not really a problem for the employees.

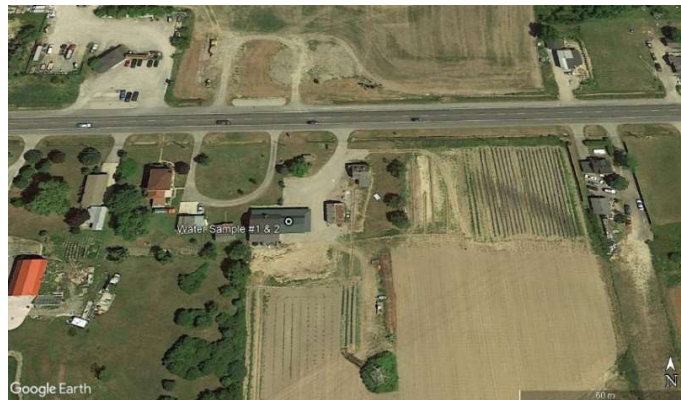
Figure 2: Satellite image of the location of water samples 1 & 2

Table 1: Work Area Sink		CDWG	In Exceedance?
Sample Location	43.079729, -79.191741	 	
Conductivity	1737 $\mu\text{S}/\text{cm}$	N/A	N/A
Temperature	7.49°C	15°C	No
Total Dissolved Solids	1267 ppm	500 ppm	Yes

pH	6.7	7.0 – 10.5	Yes
Table 2: Bathroom Sink		CDWG	In Exceedance?
Sample Location	43.079729, -79.191741		
Conductivity	1741 μ S/cm	N/A	N/A
Temperature	12.1°C	15°C	No
Total Dissolved Solids	1265 ppm	500 ppm	Yes
pH	6.78	7.0 – 10.5	Yes

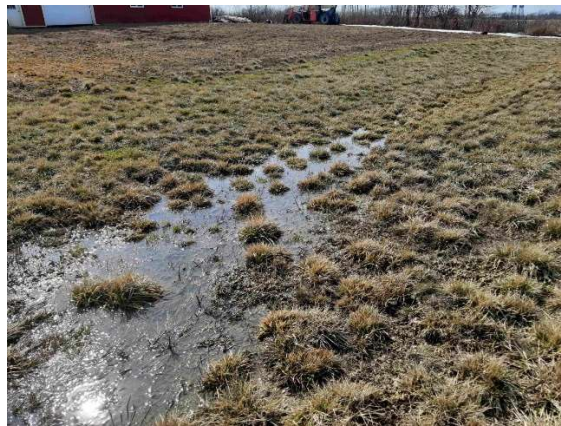
The next two were taken from the small valleys in the land that gets partially flooded during the late winter/early spring. The water flows from the east to the west.

Figure 3: Location of water sample #3

Table 3: Valley #1		Guidance	Guidance Source	In Exceedance?
Sample Location	43.0787026, -79.1913106			
Conductivity	1683 μ S/cm	N/A	N/A	N/A
Temperature	6.71°C	10°C	PWQO	No
Total Dissolved Solids	1242 ppm	500 - 800 ppm	CCME	Yes
pH	6.66	6.5 – 8.5	PWQO	No

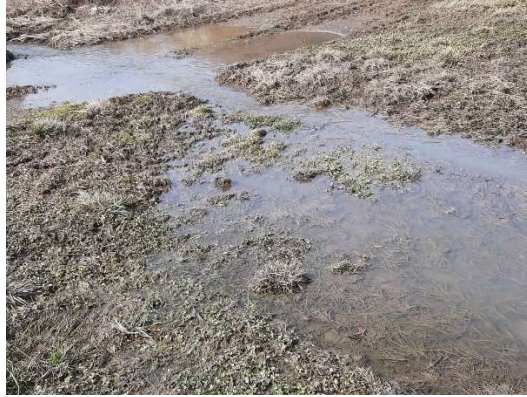
Figure 5: Location of water sample #4

Table 4: Valley #2		Guidance	Guidance Source	In Exceedance?
Sample Location	43.0781506, -79.1917176	 	 	
Conductivity	274.7 μ S/cm	N/A	N/A	N/A
Temperature	3.38°C	10°C	PWQO	No
Total Dissolved Solids	188 ppm	500 – 800 ppm	CCME	No
pH	6.52	6.5 – 8.5	PWQO	No

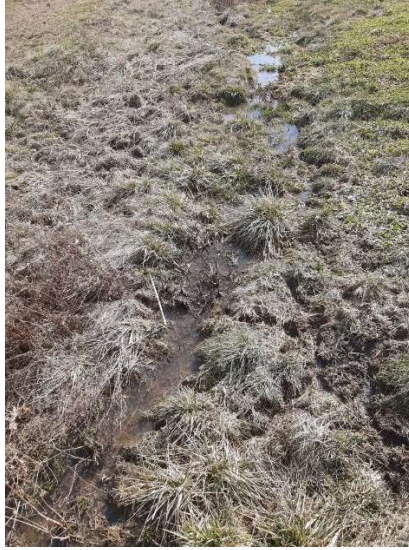
The final in-situ water sample results were from a narrow course of water at the backlot area of the property. The water flows north from the southern property line into a ditch that is full of bullrushes, then goes west.

Figure 7: Location of water sample #5

Table 5: Backlot area		Guidance	Guidance Source	In Exceedance?
Sample Location	43.0758334, -79.1907674			
Conductivity	88.97 μ S/cm	N/A	N/A	N/A
Temperature	2.37°C	10°C	PWQO	No
Total Dissolved Solids	60.74 ppm	500 – 800 ppm	CCME	No
pH	6.5	6.5 - 8.5	PWQO	No

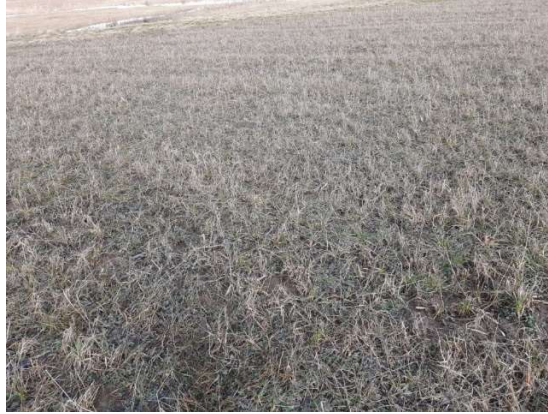
Figure 9: Location of the soil sample

A soil sample was also taken from an open field east of where the new barn is located to. No in-situ tests were done here, but measurements of the depths that each soil core was taken at were recorded.

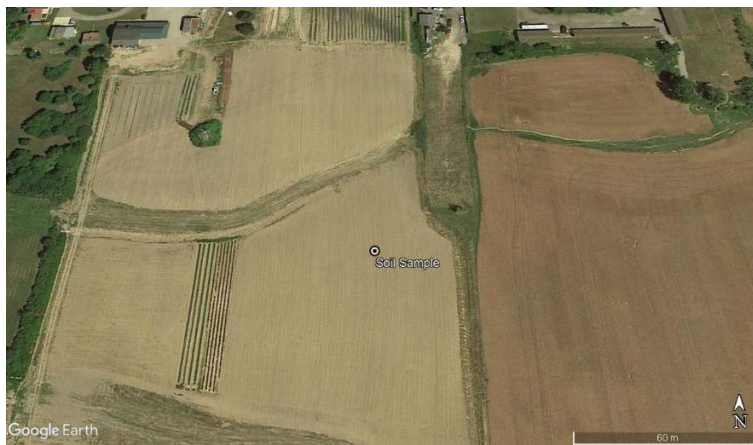
Figure 10: Satellite view of the location of the soil sample

Table 6: Field		
Diameter of hole	10.2 cm	
Cores	Depth of sample (cm)	Length of sample (cm)
Top soil	4.5	5
Sample #1	7.5	7
Sample #2	11	7
Sample #3	13.5	13.5
Sample #4	15	6
Sample #5	17	6.5
Sample #6	19.5	8

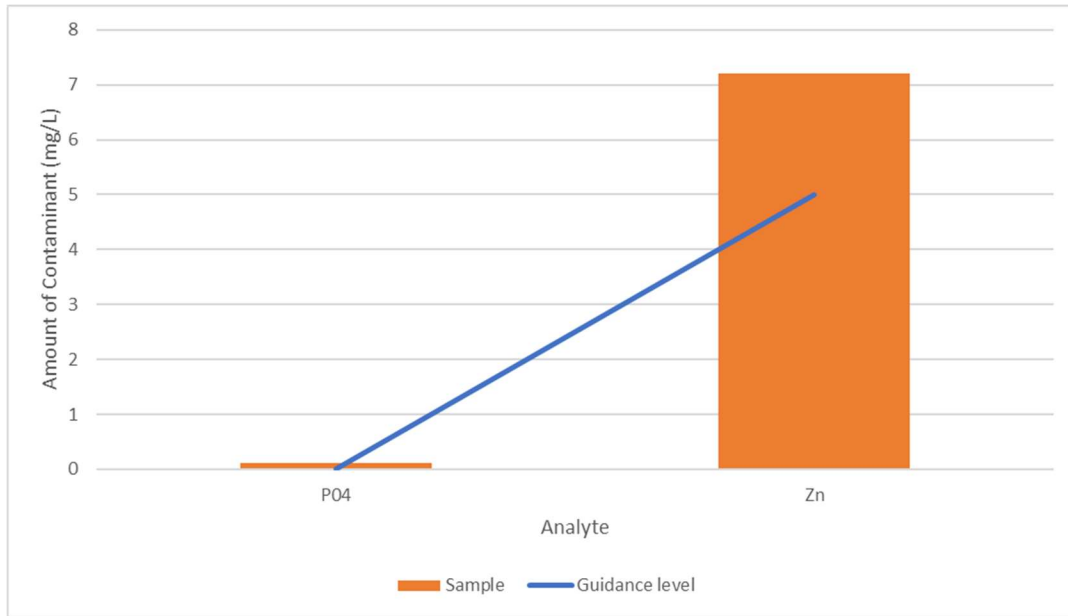
Table 7: Work Area Sink		Guidance	Guidance Source	In Exceedance?	
Turbidity	0.23 NTU	0.3 NTU	CDWG	No	
Dissolved Oxygen	93.0%	N/A	N/A	N/A	
Conductivity	2008 μ S/cm	N/A	N/A	N/A	
Temperature	10.2°C	15 °C	CDWG	No	
TDS	1480 ppm	500 ppm	CDWG	Yes	
pH	6.70	7.0 – 10.5	CDWG	Yes	
Analyte	Guidance Source	Guidance levels	Unit	Sample	In Exceedance?
P04	EPADWS	0.0005	mg/L	0.11	Yes
N-NO3	DWQO	10.0	mg/L	0	No
Arsenic (As)	DWQO	0.01	mg/L	0	No
Cadmium (Cd)	DWQO	0.005	mg/L	0.0003	No
Cobalt (Co)	EWG	0.07	mg/L	0.0004	No
Chromium (Cr)	DWQO	0.05	mg/L	0	No
Copper (Cu)	CDWG	2	mg/L	1.25	No
Mercury (Hg)	DWQO	0.001	mg/L	0	No
Molybdenum (Mo)	EPADWS	0.02	mg/L	0	No
Nickel (Ni)	EPADWS	0.7	mg/L	0.079	No
Lead (Pb)	DWQO	0.01	mg/L	0.003	No
Selenium (Se)	DWQO	0.05	mg/L	0	No
Thallium (Tl)	CWDG	0.0005	mg/L	0	No
Zinc (Zn)	CDWG	5	mg/L	7.2	No

Figure 11: Results from the Work Area Sink Water Sample in Exceedance

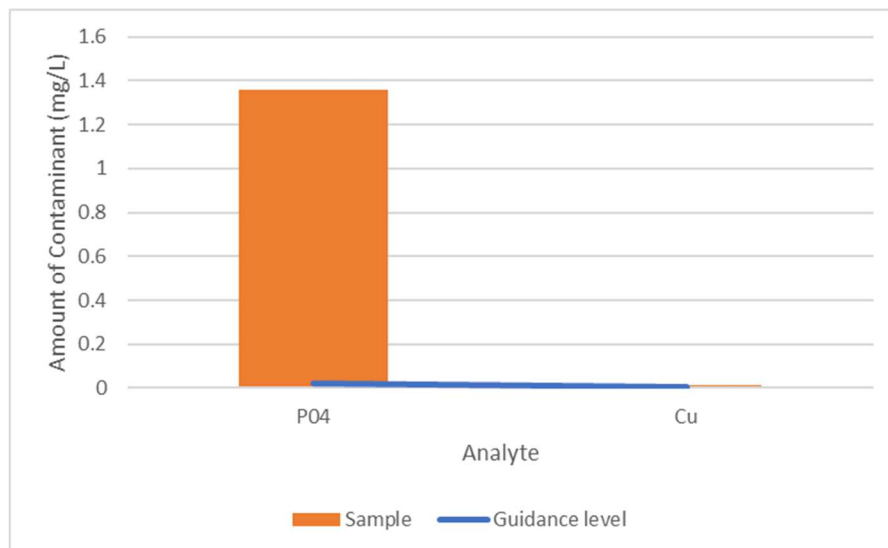
Table 9: Valley #1		Guidance	Guidance Source	In Exceedance?	
Turbidity	54.3 NTU	N/A	N/A	N/A	
Dissolved Oxygen	95.0%	54%	PWQO	No	
Conductivity	1694 μ S/cm	N/A	N/A	N/A	
Temperature	10.6°C	10°C	PWQO	Yes	
TDS	1232 ppm	500 - 800 ppm	CCME	Yes	
pH	6.90	6.5 – 8.5	PWQO	No	
Analyte	Guidance Source	Guidance levels	Unit	Sample	In Exceedance?
Phosphates (P04)	PWQO	0.02	mg/L	1.36	Yes
Nitrates (N-NO3)	CCME	550	mg/L	0.053	No
Arsenic (As)	PWQO	0.005	mg/L	<0.001	No
Cadmium (Cd)	PWQO	0.0002	mg/L	<0.0001	No
Cobalt (Co)	PWQO	0.0009	mg/L	0.0004	No
Chromium (Cr)	PWQO	0.001	mg/L	<0.001	No
Copper (Cu)	PWQO	0.005	mg/L	0.014	Yes
Mercury (Hg)	PWQO	0.0002	mg/L	<0.0001	No
Molybdenum (Mo)	PWQO	0.04	mg/L	<0.005	No
Nickel (Ni)	PWQO	0.025	mg/L	<0.005	No
Lead (Pb)	PWQO	0.001	mg/L	0.001	No
Selenium (Se)	PWQO	0.1	mg/L	<0.001	No
Thallium (Tl)	PWQO	0.0003	mg/L	<0.0001	No
Zinc (Zn)	PWQO	0.02	mg/L	<0.01	No

Figure 12: Results from the Valley #1 Water Sample in Exceedance

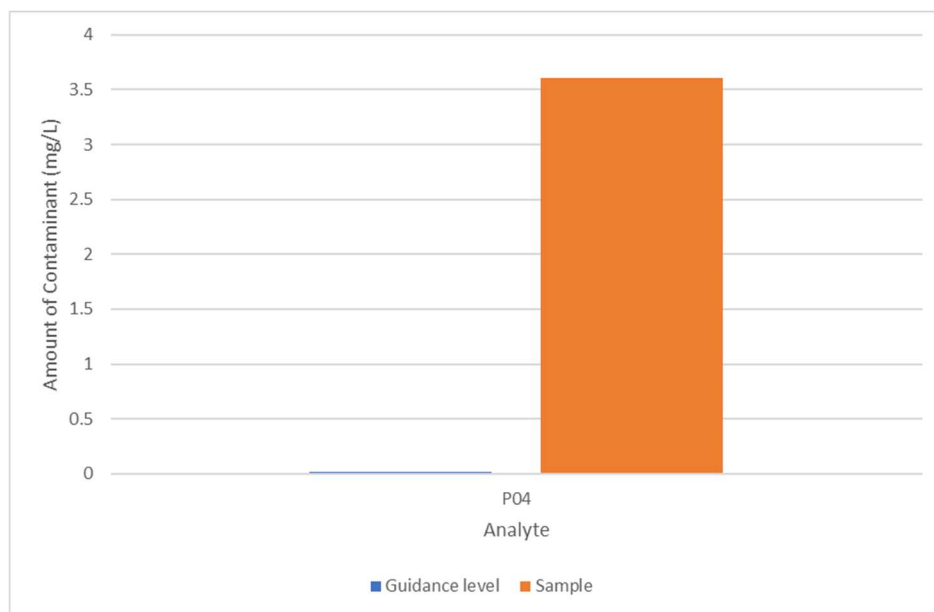
Table 10: Valley #2		Guidance	Guidance Source	In Exceedance?	
Turbidity	61.8 NTU	N/A	N/A	N/A	
Dissolved Oxygen	83.7%	54%	PWQO	No	
Conductivity	264.9 μ S/cm	N/A	N/A	N/A	
Temperature	11.8°C	10°C	PWQO	Yes	
TDS	178.5 ppm	500 - 800 ppm	CCME	Yes	
pH	6.60	6.5 – 8.5	PWQO	No

Analyte	Guidance Source	Guidance levels	Unit	Sample	In Exceedance?
Phosphates (P04)	PWQO	0.02	mg/L	3.61	Yes
Nitrates (N-NO3)	CCME	550	mg/L	0.077	No
Arsenic (As)	PWQO	0.005	mg/L	<0.001	No
Cadmium (Cd)	PWQO	0.0002	mg/L	<0.0001	No
Cobalt (Co)	PWQO	0.0009	mg/L	0.0004	No
Chromium (Cr)	PWQO	0.001	mg/L	<0.001	No
Copper (Cu)	PWQO	0.005	mg/L	0.005	No
Mercury (Hg)	PWQO	0.0002	mg/L	<0.0001	No
Molybdenum (Mo)	PWQO	0.04	mg/L	<0.005	No
Nickel (Ni)	PWQO	0.025	mg/L	<0.005	No
Lead (Pb)	PWQO	0.001	mg/L	<0.001	No
Selenium (Se)	PWQO	0.1	mg/L	<0.001	No
Thallium (Tl)	PWQO	0.0003	mg/L	<0.0001	No
Zinc (Zn)	PWQO	0.02	mg/L	<0.01	No

Figure 13: Results from the Valley #2 Water Sample in Exceedance

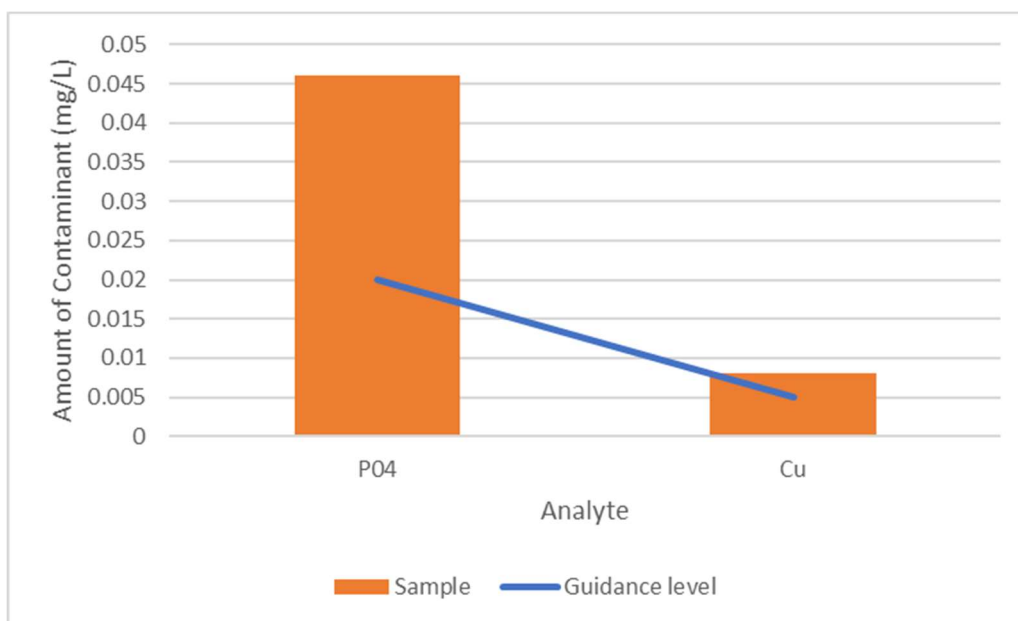
Table 11: Backlot		Guidance	Guidance Source	In Exceedance?	
Turbidity	39.4 NTU	N/A	N/A	N/A	
Dissolved Oxygen	97.3%	54%	PWQO	No	
Conductivity	98.63 μ S/cm	N/A	N/A	N/A	
Temperature	13.6°C	10°C	PWQO	Yes	
TDS	64.97 ppm	500 - 800 ppm	CCME	No	
pH	6.57	6.5 – 8.5	PWQO	No

Analyte	Guidance Source	Guidance levels	Unit	Sample	In Exceedance?
Phosphates (P04)	PWQO	0.02	mg/L	0.046	Yes
Nitrates (N-NO3)	CCME	550	mg/L	0.13	No
Arsenic (As)	PWQO	0.005	mg/L	<0.001	No
Cadmium (Cd)	PWQO	0.0002	mg/L	<0.0001	No
Cobalt (Co)	PWQO	0.0009	mg/L	0.0004	No
Chromium (Cr)	PWQO	0.001	mg/L	<0.001	No
Copper (Cu)	PWQO	0.005	mg/L	0.008	Yes
Mercury (Hg)	PWQO	0.0002	mg/L	<0.0001	No
Molybdenum (Mo)	PWQO	0.04	mg/L	<0.005	No
Nickel (Ni)	PWQO	0.025	mg/L	<0.005	No
Lead (Pb)	PWQO	0.001	mg/L	0.001	No
Selenium (Se)	PWQO	0.1	mg/L	<0.001	No
Thallium (Tl)	PWQO	0.0003	mg/L	<0.0001	No
Zinc (Zn)	PWQO	0.02	mg/L	<0.01	No

Figure 14: Results from the Backlot Water Sample in Exceedance

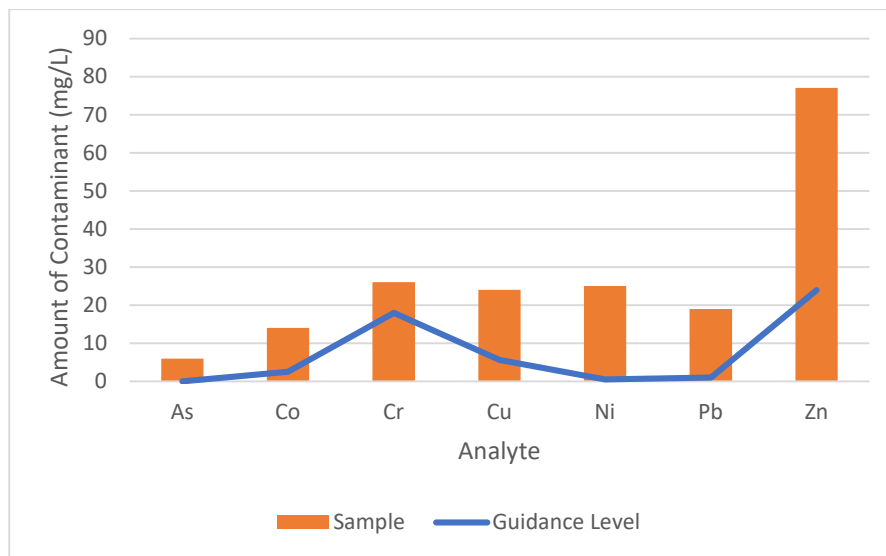
Analyte	Guidance Source	Guidance	Unit	Sample	In Exceedance?
P (NaHCO ₃ Extractable)	n/a	n/a	mg/L	5	n/a
N-NO ₃ (KCl extractable)	n/a	n/a	mg/L	3	n/a
Conductivity	CCME	2	mS/cm	0.2	No
pH	CCME	6 to 8	mg/L	6.83	No
As	PSQO	0.047	mg/L	6	Yes
Cd	PSQO	0.0079	mg/L	<0.4	No
Co	PSQO	2.5	mg/L	14	Yes
Cr	PSQO	18	mg/L	26	Yes
Cu	PSQO	5.6	mg/L	24	Yes
Hg	PSQO	30	mg/L	<0.1	No
Mo	PSQO	1.2	mg/L	<1	No
Ni	PSQO	0.510	mg/L	25	Yes
Pb	PSQO	1	mg/L	19	Yes
Se	PSQO	1.2	mg/L	<1	No
Tl	PSQO	0.033	mg/L	<1	No
Zn	PSQO	24	mg/L	77	Yes

Figure 15: Results From Soil Sample in Exceedance

The amount of contamination in the soil is more of a concern, but amount of heavy metals is probably because of the fertilizers and pesticides that are used in the area or nearby. Assuming crops are planted in the area this year, there shouldn't be a problem, as they would absorb these contaminants.

- plant crops in the field from where the soil sample was taken to absorb the contamination;
- if more information is needed about the level of nutrients in the soil, have an intern in a future term continue the research to discover if the levels are in exceedance or not.

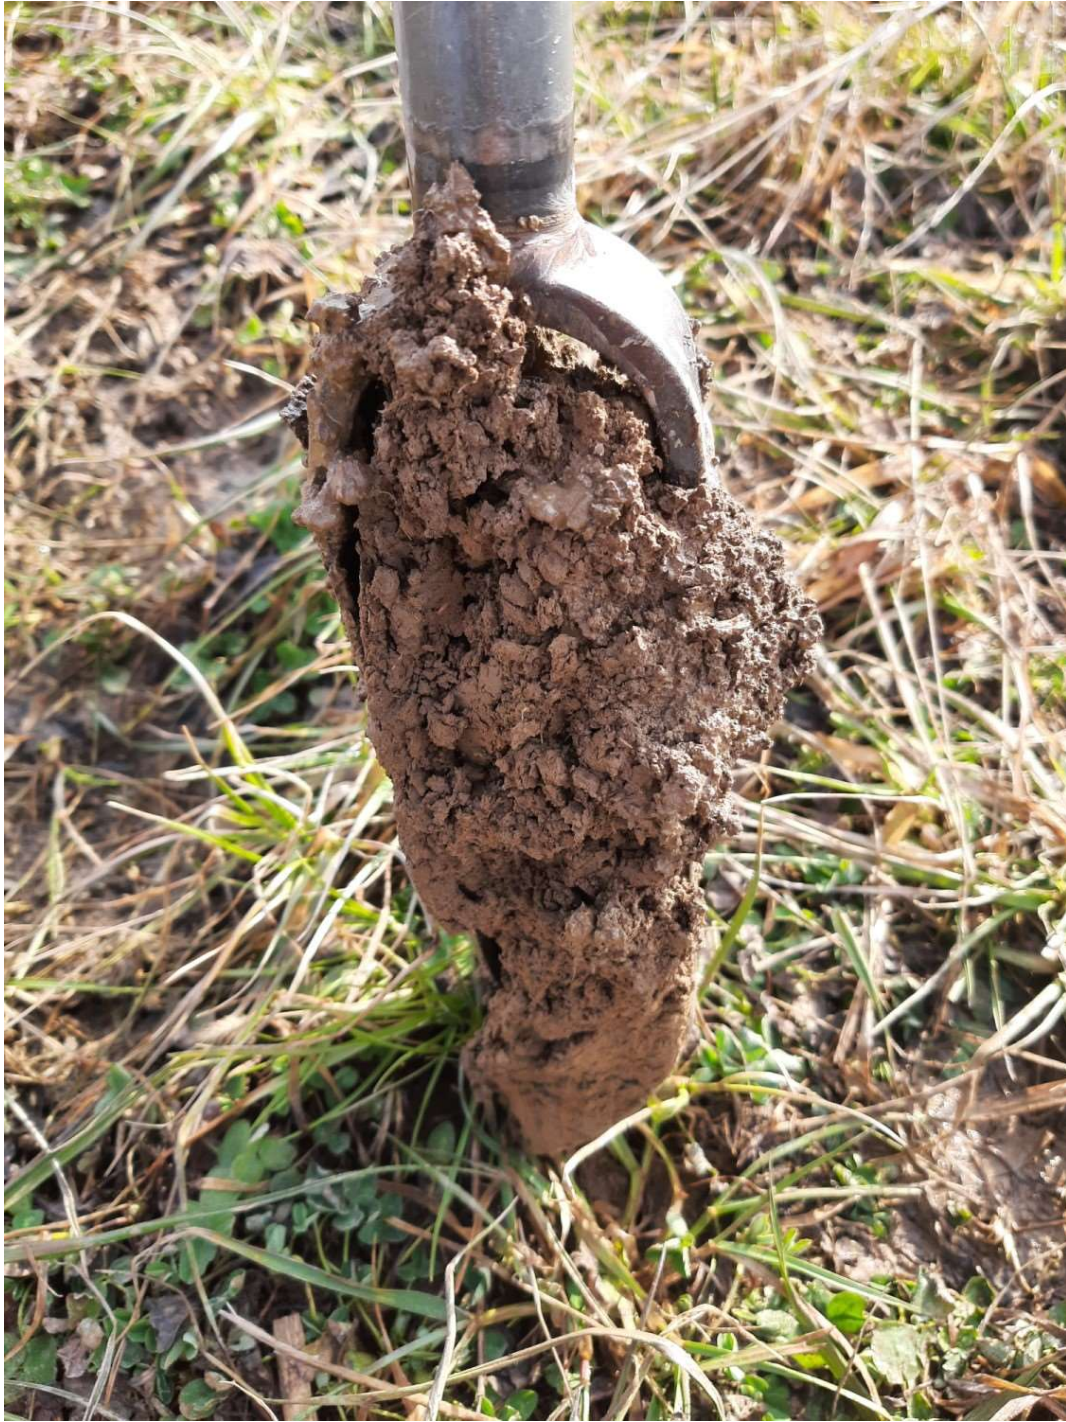
Table 12: Soil Sample #1	
Colour	Dark Brown
Munsell Value	7.5 yr 3/6
Mottle	Absent
Texture	Rough
Structure	Strong
Consistence	Moist
Length of Ribbon Formed	6 cm
Soil Type	Silty Clay

Figure 17: Soil Core Sample #1

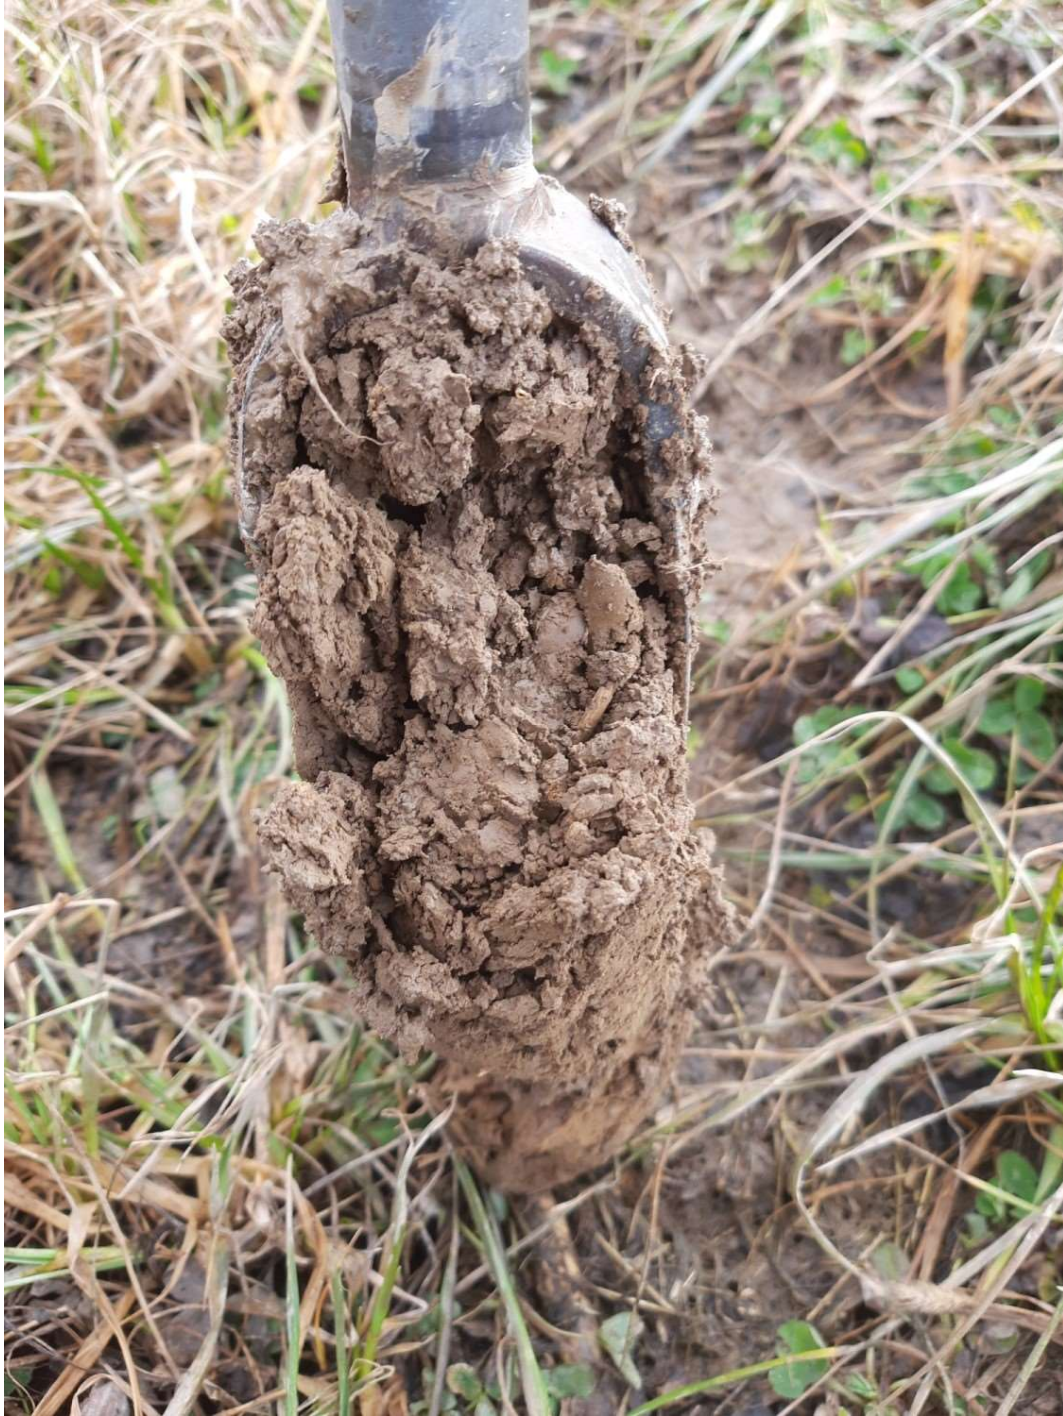
Table 13: Soil Sample #2	
Colour	Dark Brown
Munsell Value	5 yr 2/6
Mottle	Absent
Texture	Smooth
Structure	Weak
Consistence	Wet
Length of Ribbon Formed	4 cm
Soil Type	Silty Clay Loam

Figure 18: Soil Core Sample #2

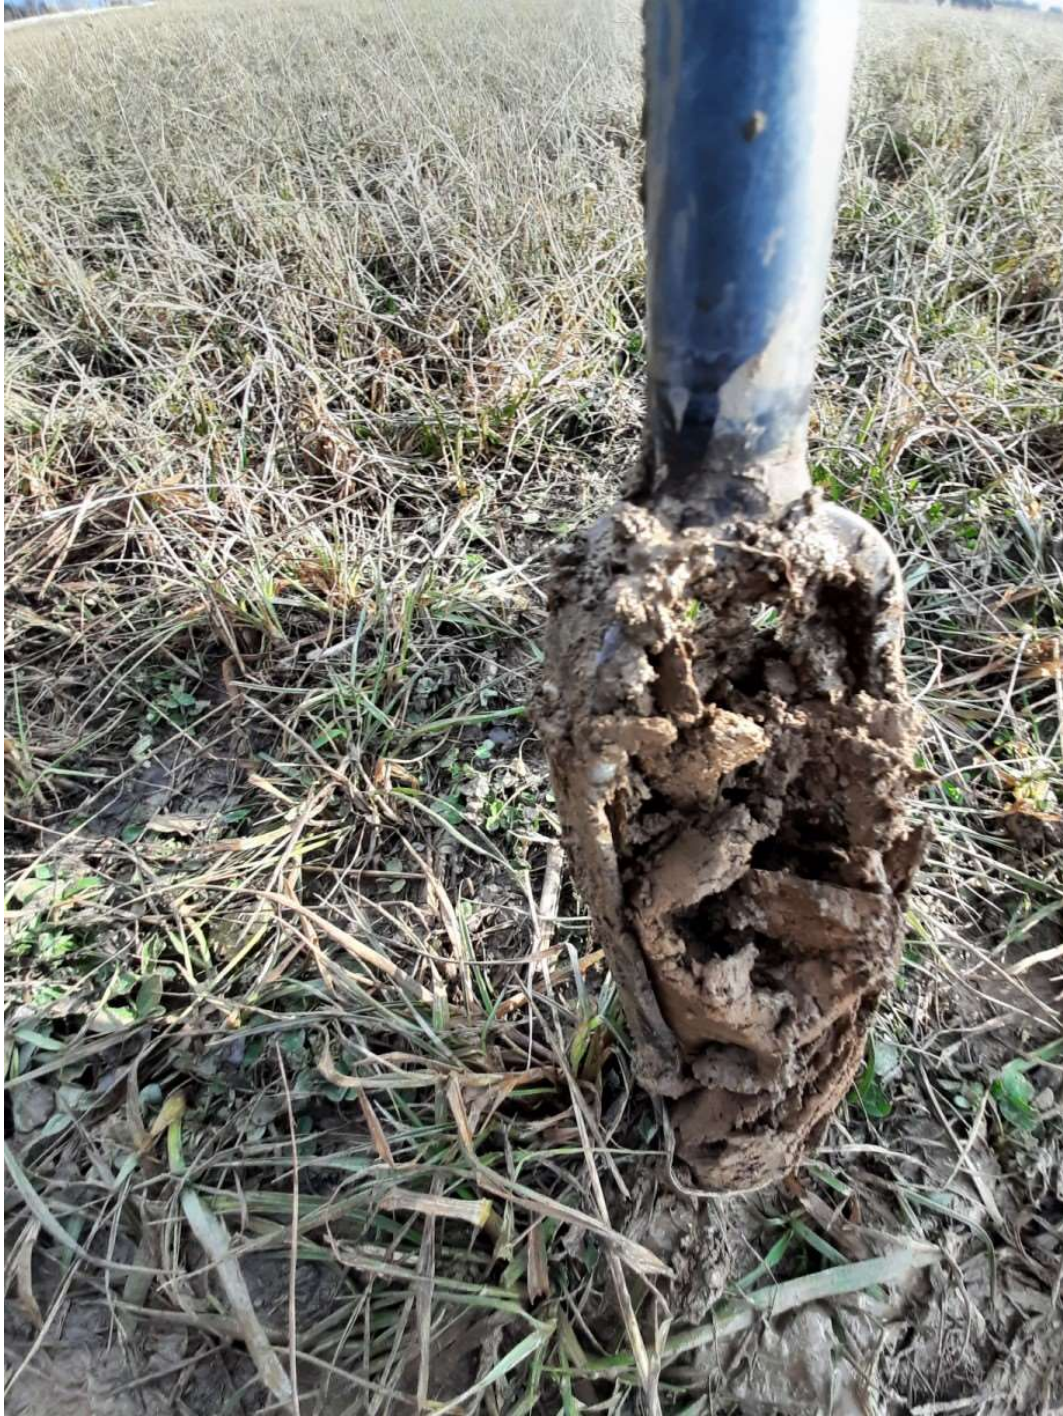
Table 14: Soil Sample #3	
Colour	Dark Brown
Munsell Value	7.5 yr 4/4
Mottle	Absent
Texture	Smooth
Structure	Strong
Consistence	Wet
Length of Ribbon Formed	5.5 cm
Soil Type	Silty Clay

Figure 19: Soil Core Sample #3

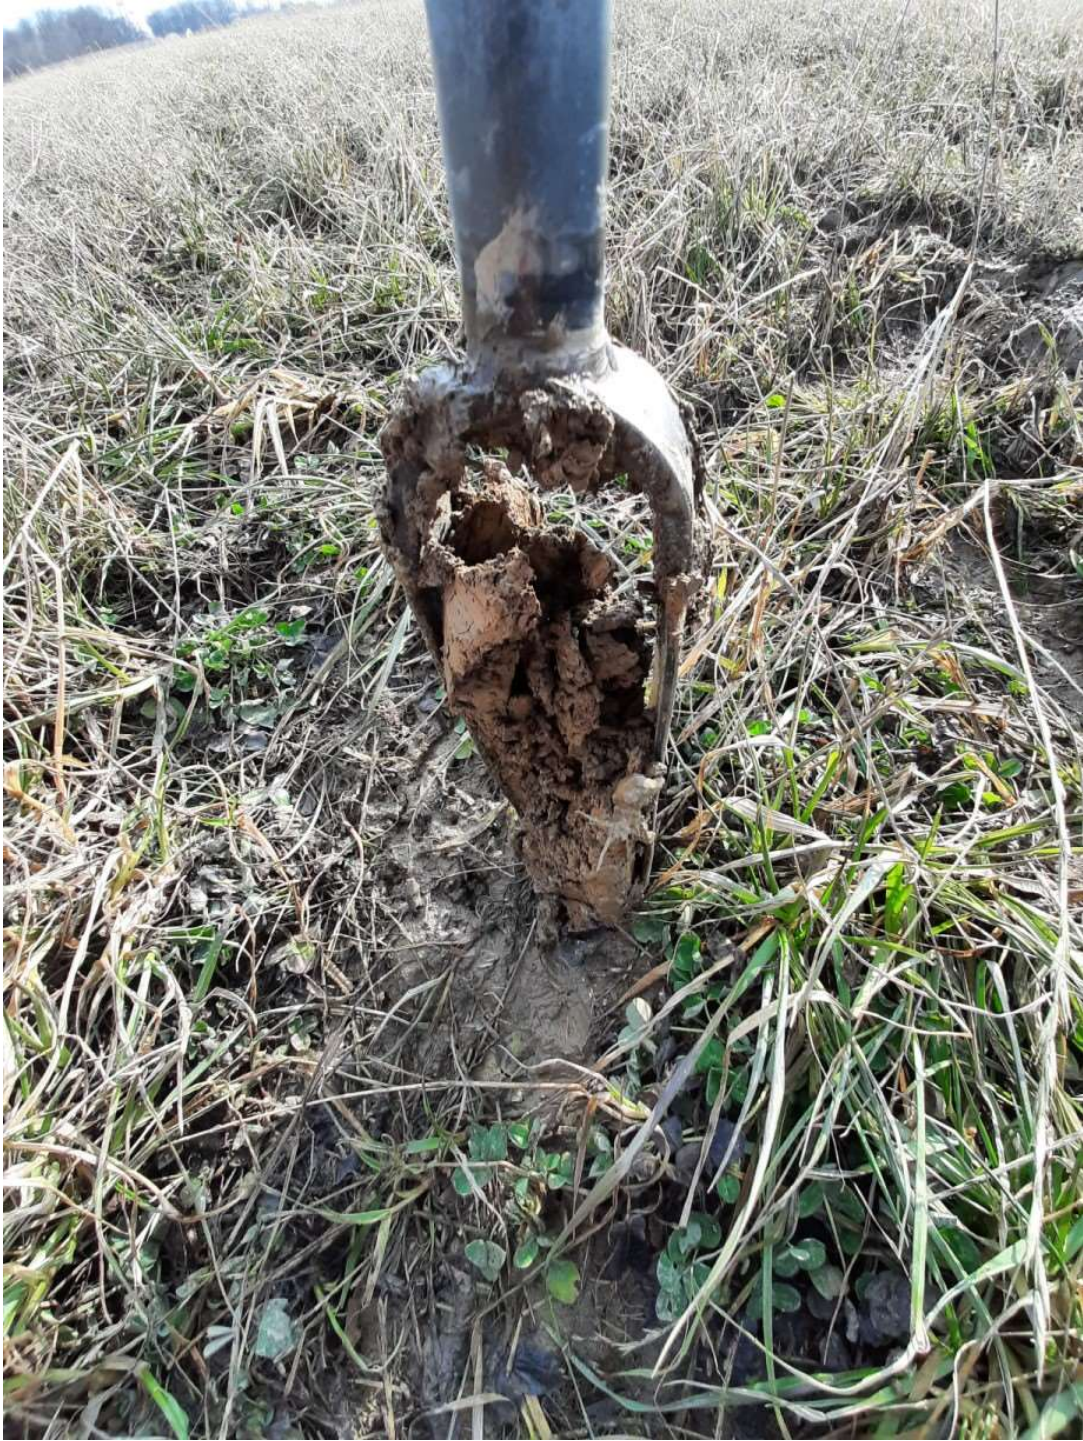
Table 15: Soil Sample #4	
Colour	Dark Brown
Munsell Value	7.5 yr 2/4
Mottle	Absent
Texture	Smooth
Structure	Strong
Consistence	Moist
Length of Ribbon Formed	5.8 cm
Soil Type	Silty Clay

Figure 20: Soil Core Sample #4

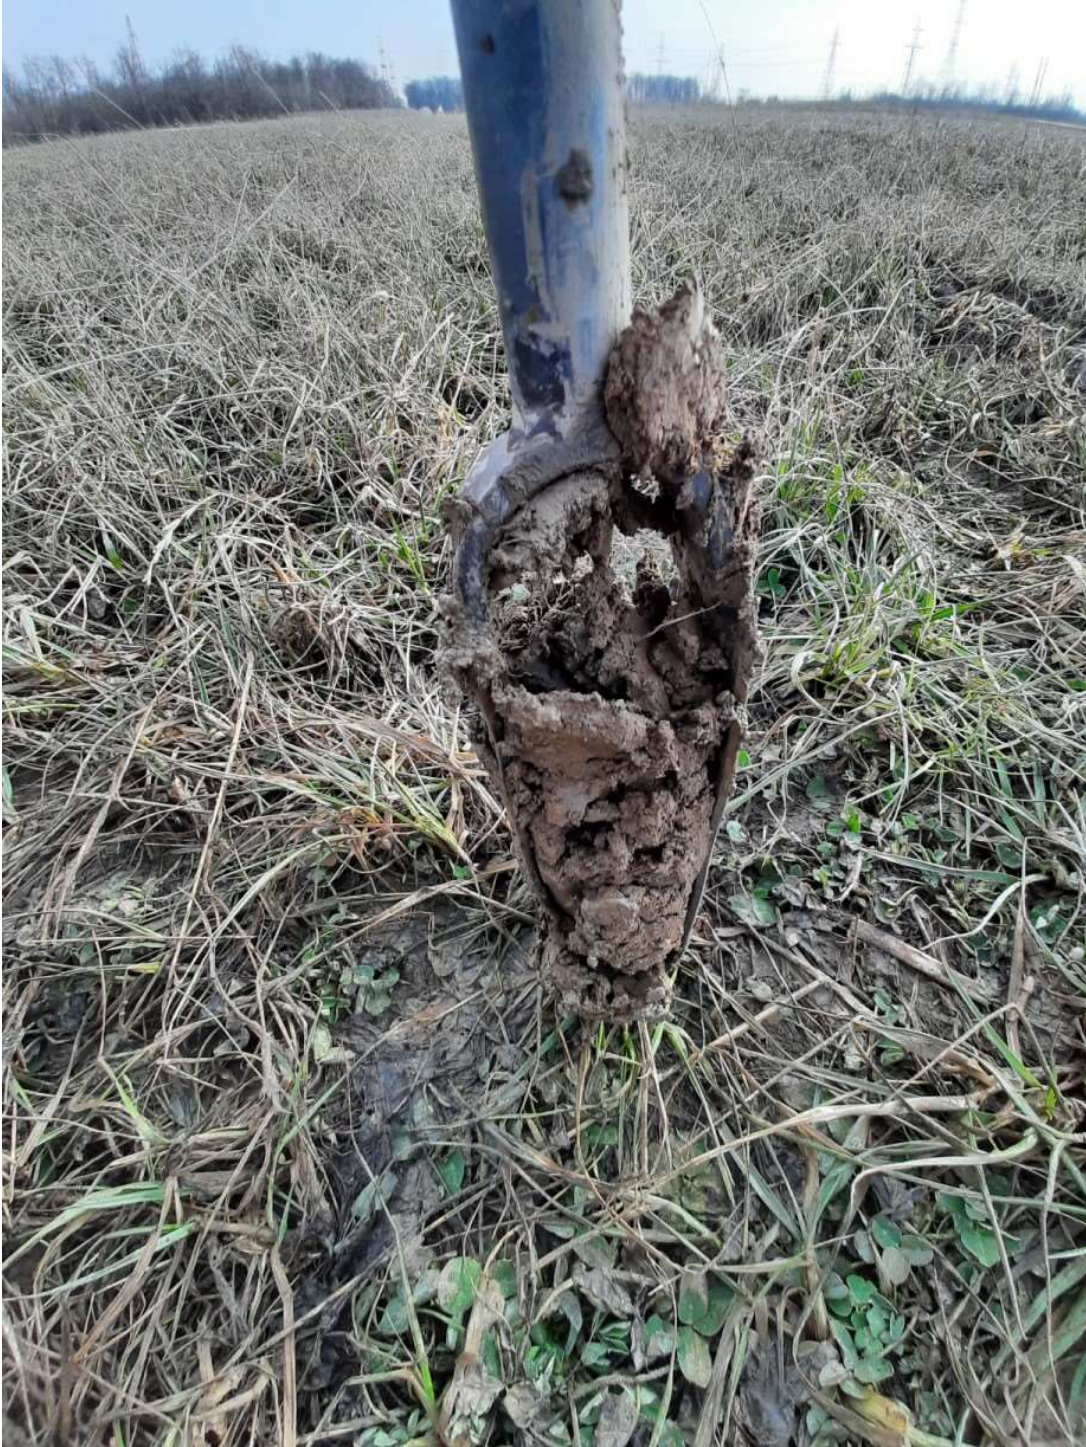
Table 16: Soil Sample #5	
Colour	Dark Brown
Munsell Value	7.5 yr 2/3
Mottle	Absent
Texture	Smooth
Structure	Strong
Consistence	Moist
Length of Ribbon Formed	6 cm
Soil Type	Silty Clay

Figure 21: Soil Core Sample #5

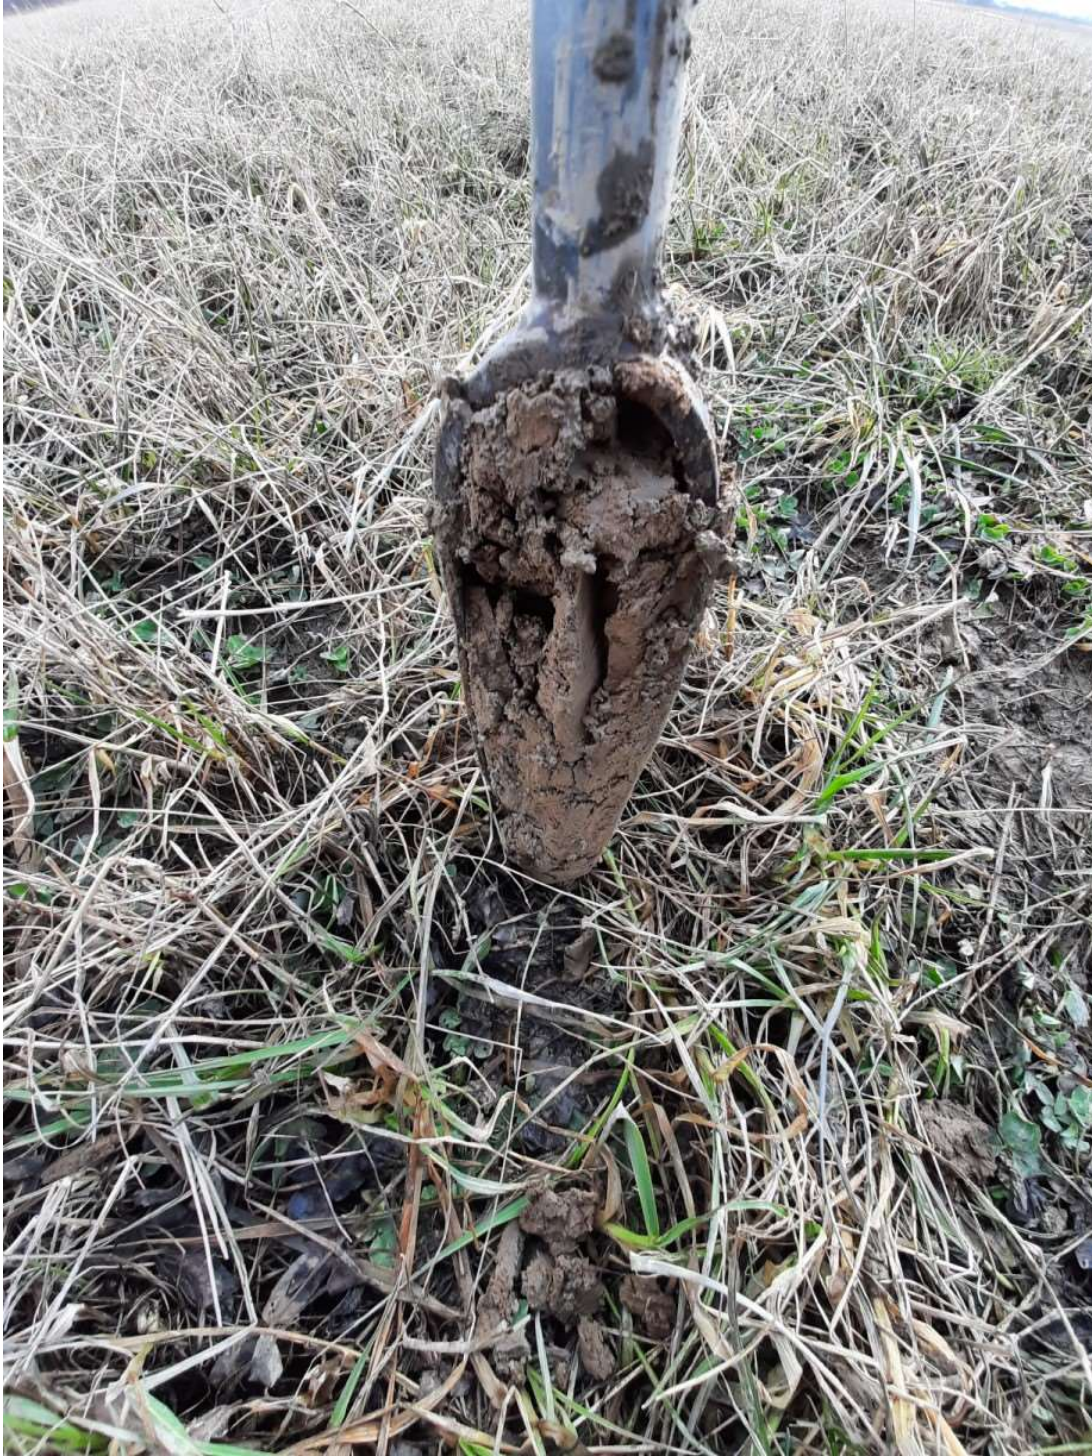
Table 17: Soil Sample #6	
Colour	Dark Brown
Munsell Value	7.5 yr 2/3
Mottle	Absent
Texture	Smooth
Structure	Strong
Consistence	Wet
Length of Ribbon Formed	5.5 cm
Soil Type	Silty Clay

Figure 22: Soil Core Sample #6
